June 2, 2022
PanGEO Project No. 21-094

Subject: Supplemental Report - Landslide Hazard Review
 Carbon Treatment Facilities
 Bell Hill and Hoffman Hill, DuPont, Washington

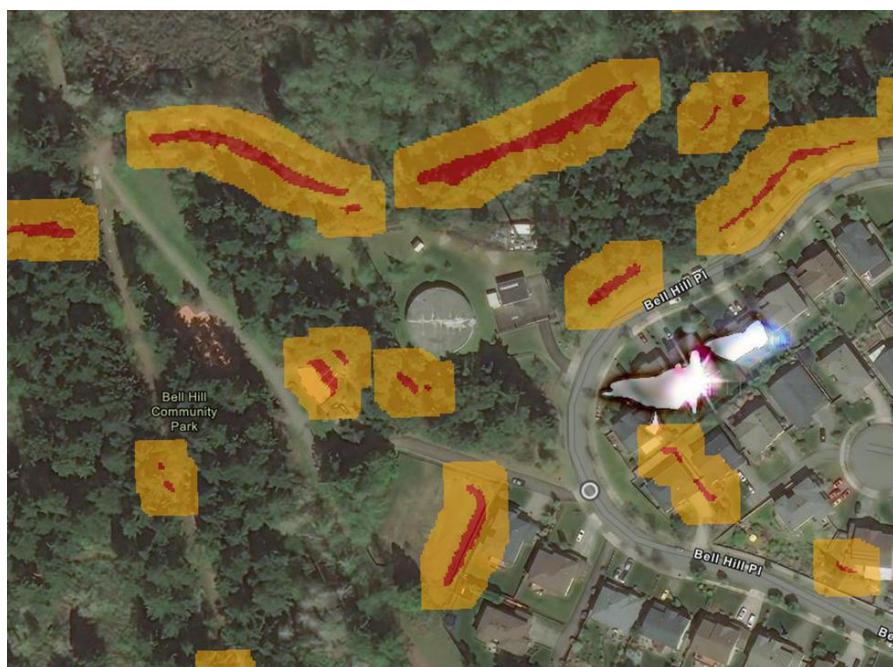
Bell Hill Site - Mapped landslide susceptibility (source: Washington State Department of Natural Resources)

According to the DNR Website, an area located downslope of the proposed Carbon Treatment facility at Bell Hill is mapped as susceptible to shallow instabilities. However, the area of the proposed construction is not mapped as susceptible to slope instabilities.

No sign of landslide scarps is located in the area, and the slope is not mapped as susceptible to deep-seated failures.

The mapped surficial landslide risk, or surficial sloughing, is likely due to the steepness of the slope. Any surficial instabilities on the slope should not extent into the proposed construction area.

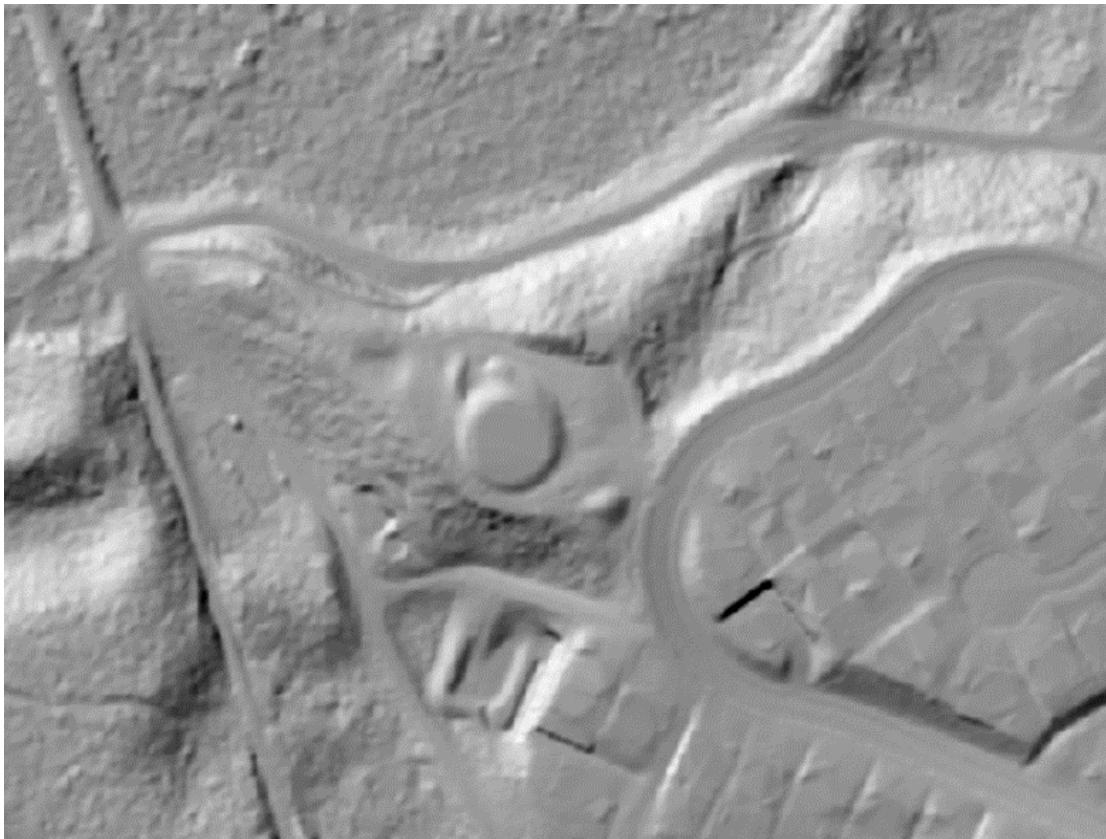
Bell Hill Site – LiDAR Imagery

The existing slope adjacent to the construction area is between 40 and 50% gradient and is taller than 10 feet. However, based on the review of LiDAR image (below), we believe that the slope was created by previous grading activities associated with the construction of the existing facility. Since the slope immediately adjacent to the proposed construction area was graded to no steeper than 2H:1V (i.e., 50% slope), which is consistent with the current standard of practice for competent soils, the slope should not be considered a landslide hazard area.

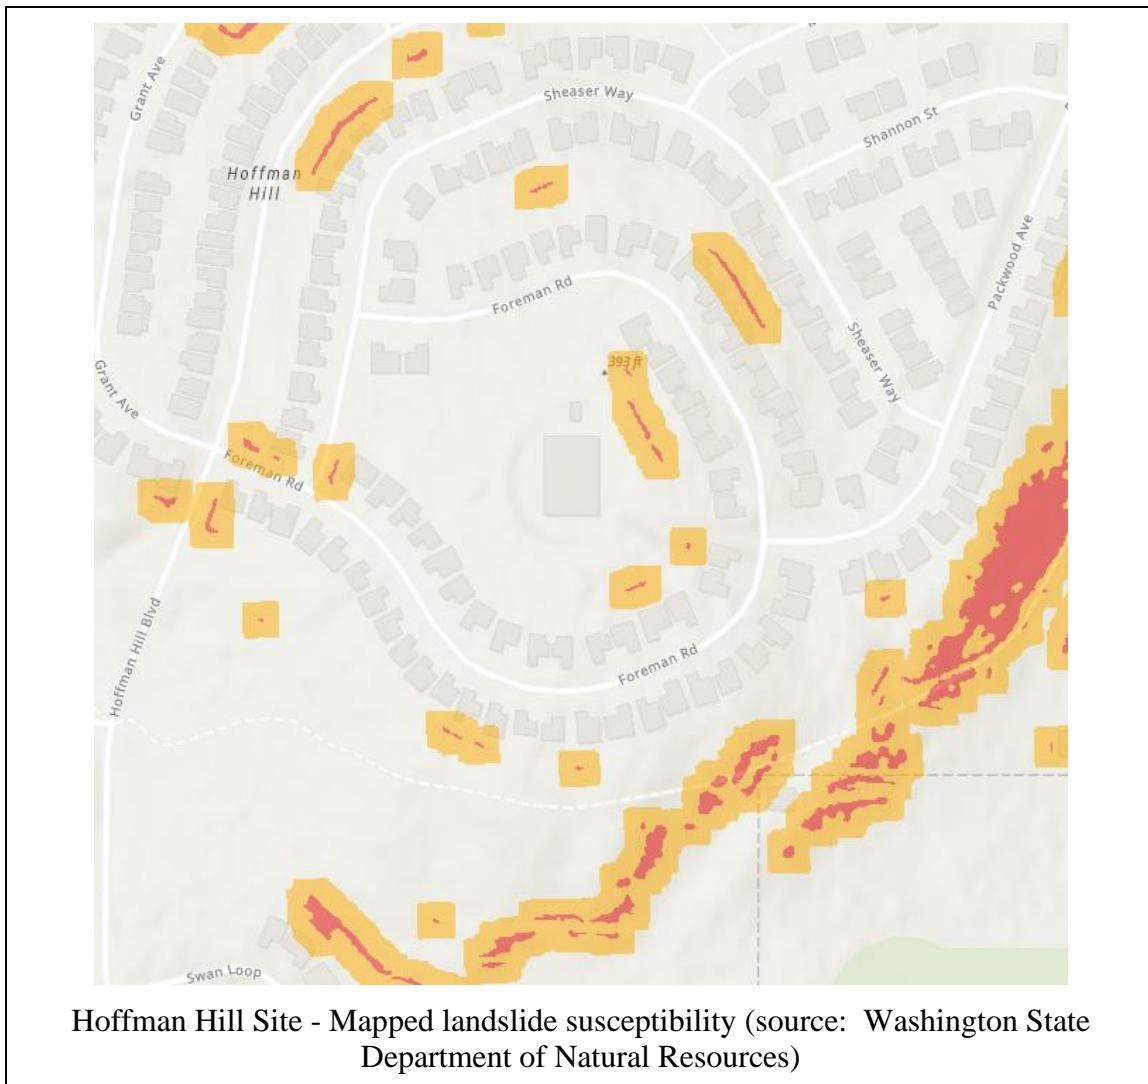
According to the DNR Website, the area located downslope of the proposed Carbon Treatment facility at Hoffman Hill is mapped as susceptible to shallow instabilities (i.e., surficial sloughing and erosions), but not at risk of deep-seated landslides. No signs of landslide scars are located in the area

The area of the proposed construction is not mapped as susceptible to slope instabilities.

The mapped surficial landslide risk located downslope of the construction area is likely due to the steepness of the slope. Any surficial instabilities on the slope should not extend into the proposed construction area.

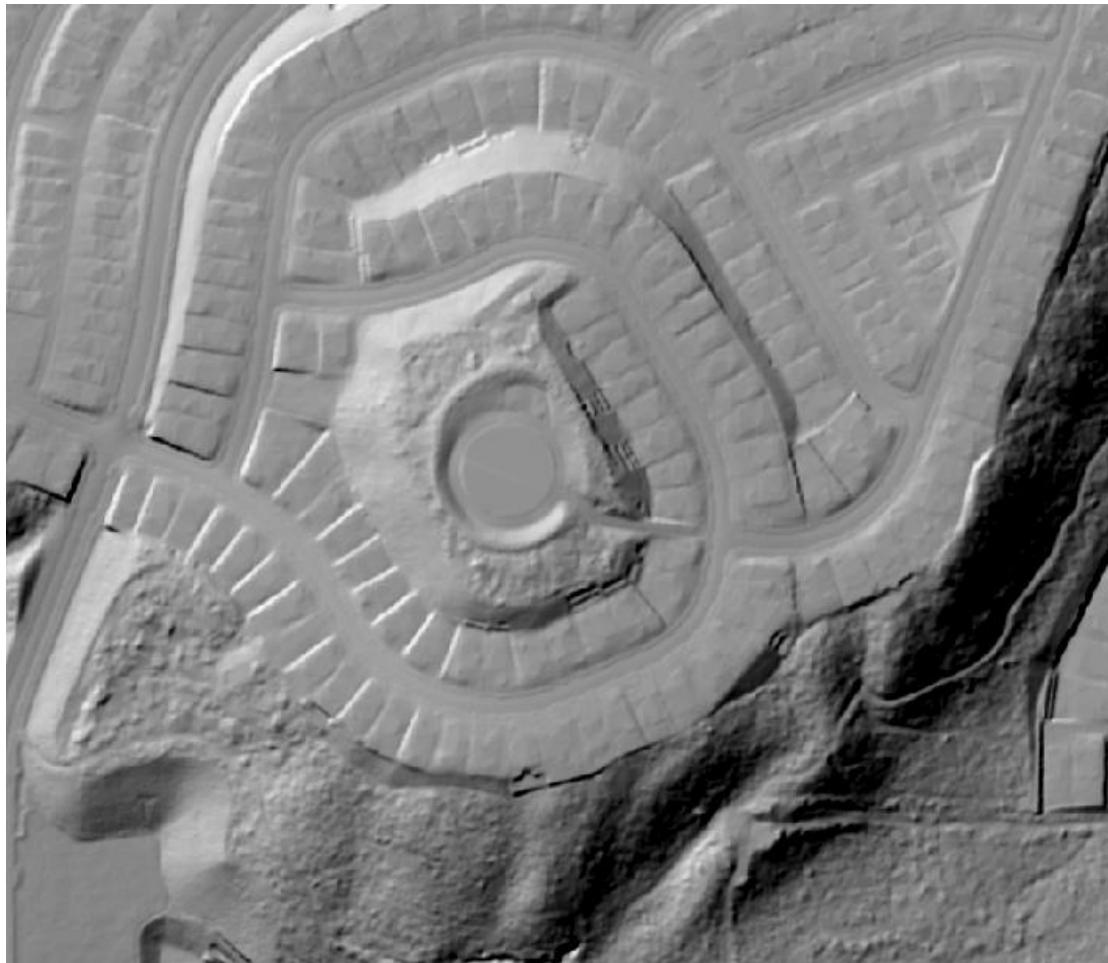
Hoffman Hill Site – LiDAR Imagery

The slope in question is located between the project site and the residential dwellings located below and east of the site. Based on the review of LiDAR image (below), the slope surface is very uniform and appears artificial. It is our opinion that the slope was previously graded, likely associated with the construction of the existing houses. The slope was graded no steeper than 2H:1V (i.e., 50% slope) based on Pierce County mapping. Since the slope was previously designed and graded to a slope gradient that is consistent with the current standard of practice for competent soils, the slope should not be considered a landslide hazard area.
