- Tree Retention Plan-

### DuPont West

1700 Center Drive  
DuPont, WA

Report Date: October 26, 2023

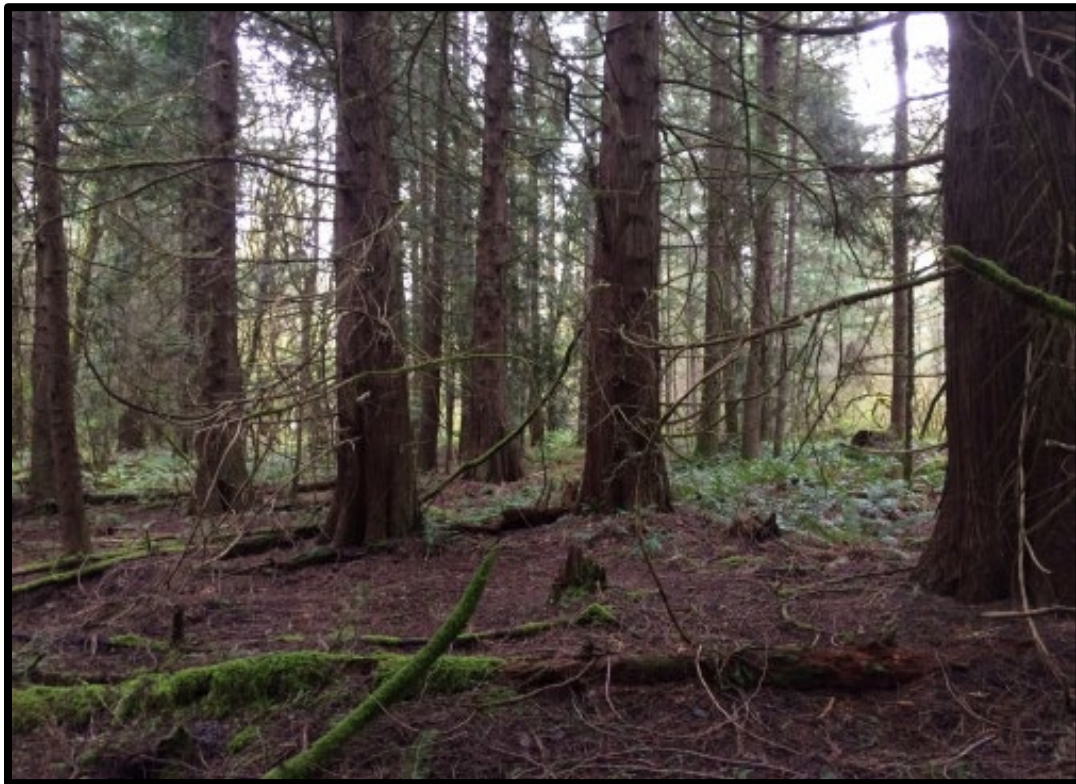
**Type I.** – This type is a mixed stand of deciduous and conifer trees. It covers 13.55-acres and includes all the Specimen, Landmark, and Significant trees on the site that are 4 inches and larger in diameter. There are 669 trees in this type that had their tree location surveyed. The tree species include Douglas-fir (*Pseudotsuga menziesii*), western hemlock (*Tsuga heterophylla*), western redcedar (*Thuja plicata*), Oregon white oak (*Quercus garryana*), Pacific yew (*Taxus brevifolia*), Pacific madrone (*Arbutus menziesii*), and bigleaf maple (*Acer macrophyllum*). Tree size ranges from 4 to over 50 inches DBH. Tree condition ranges from ‘Poor’ to ‘Good’, with most trees described as being in the ‘Fair’ or ‘Good’ condition class. Table 1 is a summary of trees located on the project site. A complete list of Landmark trees located on-site is found in Attachment 3.

Photo 1: View of typical trees in Cover Type I

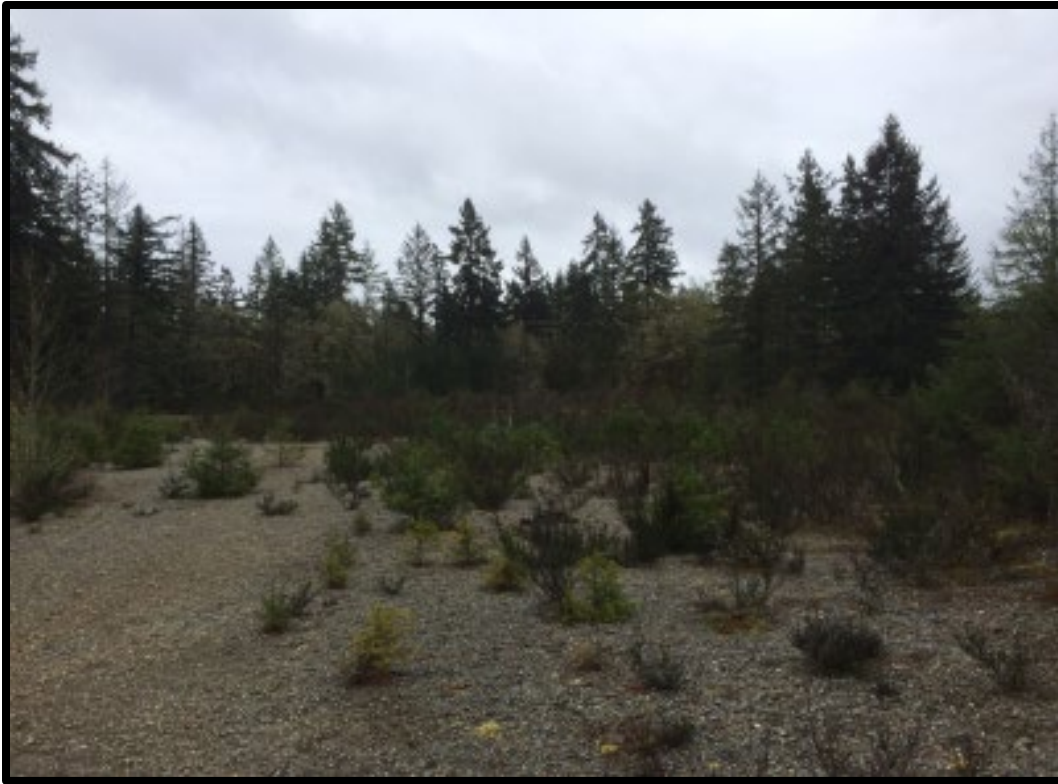
**Type II.** – This 6.10-acre cover type consists of mostly open, highly disturbed ground with only small thickets of young Douglas-fir trees. No trees were inventoried or surveyed in this Type. Other vegetation in this area includes abundant Scotch broom (*Cytisus scoparius*), grasses, and broadleaf weeds.

**Photo 2: Non-forest Cover Type II**

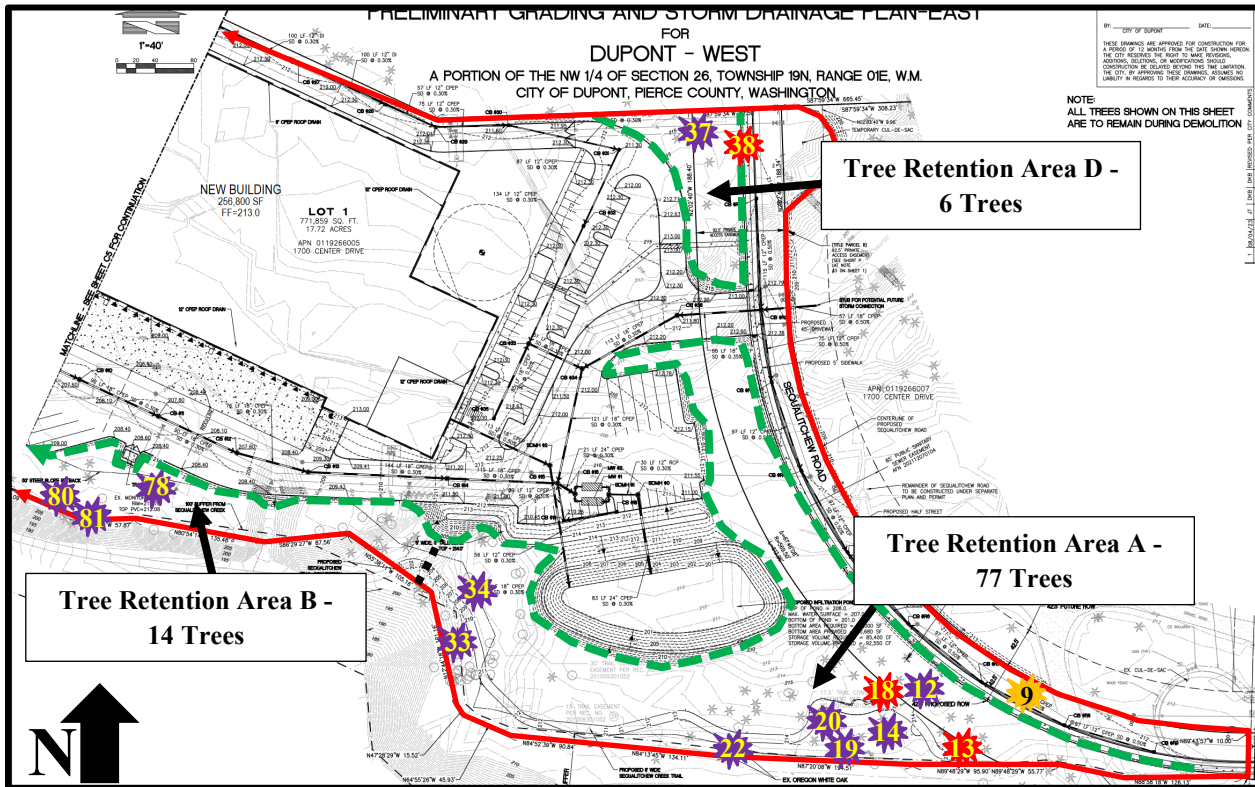
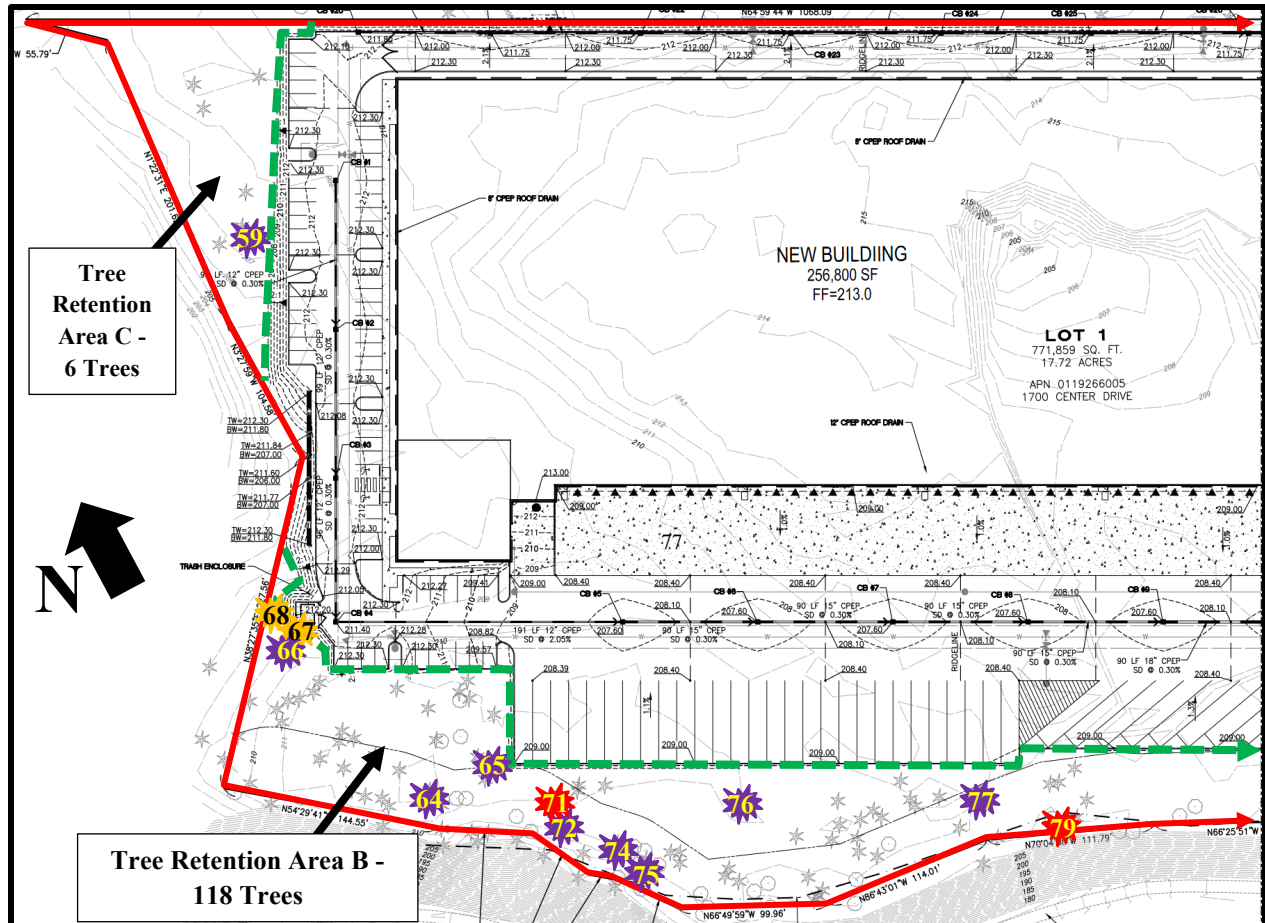
## Attachment 2. DuPont West Site Plan/Tree Map with Landmark Tree Locations Indicated

Locations of landmark trees are indicated on the site plan (Attachment #2). A total of **19** healthy landmark trees can be retained on the site. Fifty-six (**56**) landmark trees will need to be removed because they are either unhealthy or located under the footprint of proposed buildings, roads, storm ponds, or parking lots. Other than Oregon white oak, there is no requirement to retain these landmark trees under the footprint of the buildings, storm ponds, and parking lots, as long as tree retention is achieved in the street boundaries and abutting a residential district. All landmark trees are labeled with a blue number at the base corresponding to the table in Attachment 3.

**The proposed location and paving of the proposed Sequalitchew Creek Trail bisects the CRZ of multiple trees in Tree Retention Area A. A Certified Arborist® should be on-site during work in this area to re-evaluate the health of the trees and assess the path alignment to determine the proper method to protect the roots of the save trees. The path follows the existing grade so little soil disturbance will occur. The overall impact of the trail withing the CRZ of the save trees is minimal compared to the entire root zones of the trees. If the trees are healthy, they will be able to tolerate some root impact.**

**Root impact could be reduced using root protection strategies such as structural soil under the pathway or installing a passive aeration under the path. Structural soils are soils that are specially designed to provide nutrients, space, and porosity to accommodate root growth while also allowing for compaction to support pavement without settling. This will protect the roots of the tree and allow for the pathway.**

**The work on the pathway should be confined only to the path area. Tree protection fences should be placed along the sides of the path. The path should be constructed with structural soils as progress is made to prevent root compaction and damage. The on-site arborist should prescribe any pruning or other tree maintenance on a tree-by-tree basis to promote tree health. The health of the trees should be monitored for 3 years after the path has been constructed.**
