Arborist Report

RE: Champions Centre Arborist Report, DuPont WA

September 6, 2023

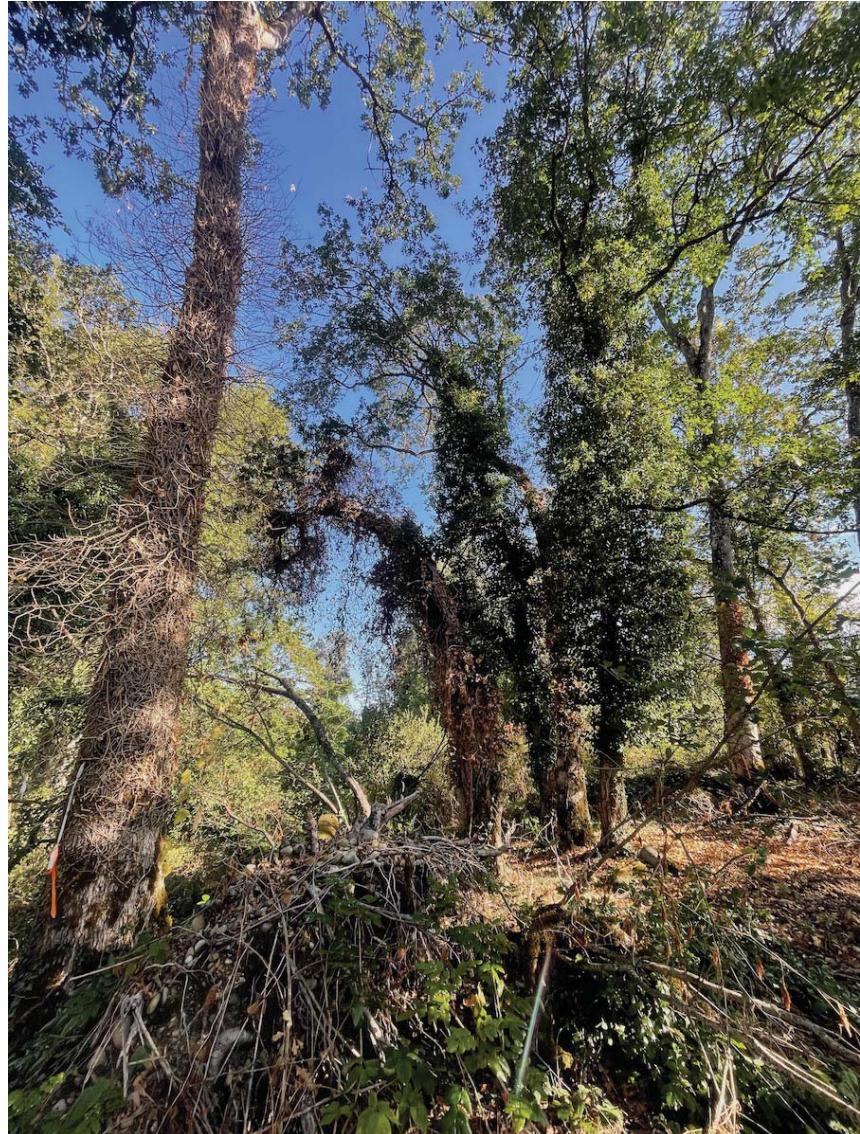
Overall, these oaks are in fair to poor condition, and for two (2) primary reasons: neglect (resulting in competition from invasive bramble and vines), and poor structure (from close proximity to each other resulting in competition for light and space).

The image right, and also on the following page, show the disarray of this grove of oak trees. Invasive bramble and vine has dominated both the understory of the forest floor, and also the upper canopy of several trees.

The invasive bramble has out competed native understory shrubs within the stand, and also competes with the oaks for available rainwater.

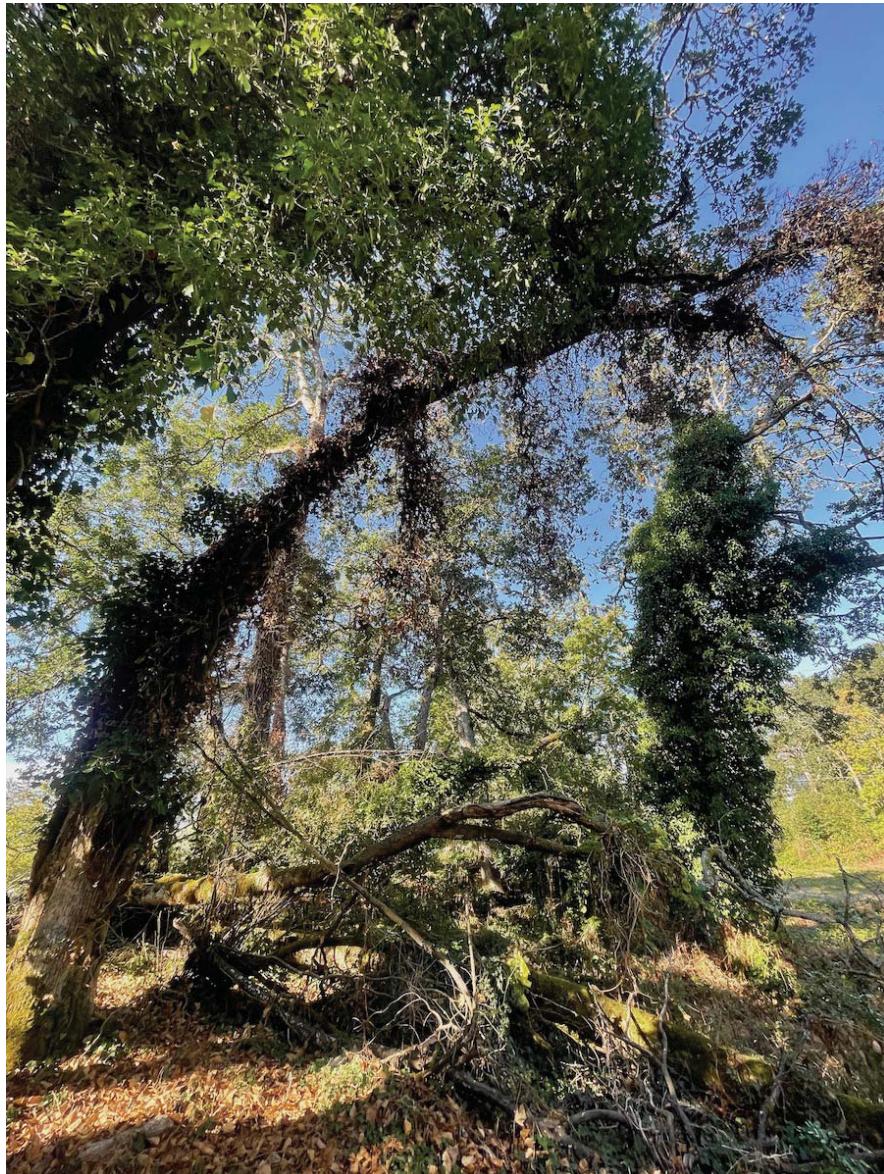
Several tree trunks are covered in dense ivy, some recently cut and killed, and some still living. The dense ivy competes for light and space, resulting in skinny trees (a high height/diameter ratio, or H/D) and tall trees with few or no low branches (low live crown ratio (LCR)). The result is stressed and poorly formed trees. These conditions of slenderness and low LCR affect tree health and stability as evidenced by an oak recently pulled to the ground by the dense ivy.

Removal of the ivy is insufficient to cause the trees to grow new low branches on their trunks, reversing the H/D and LCR conditions, partly because of species characteristics, and particularly because of their existing close proximity to each other.

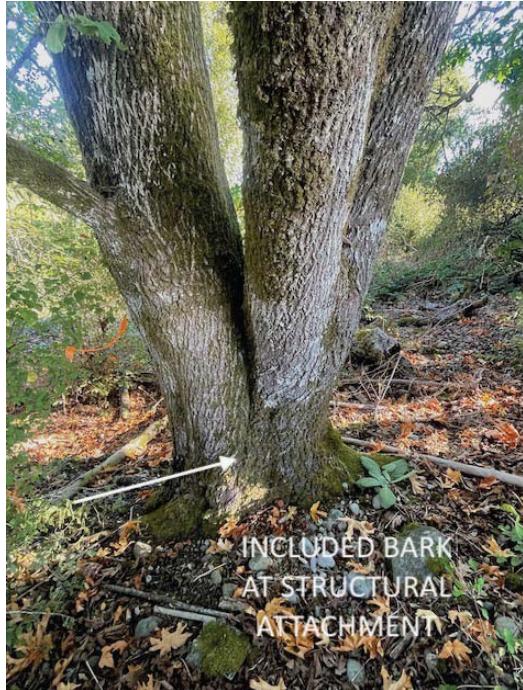
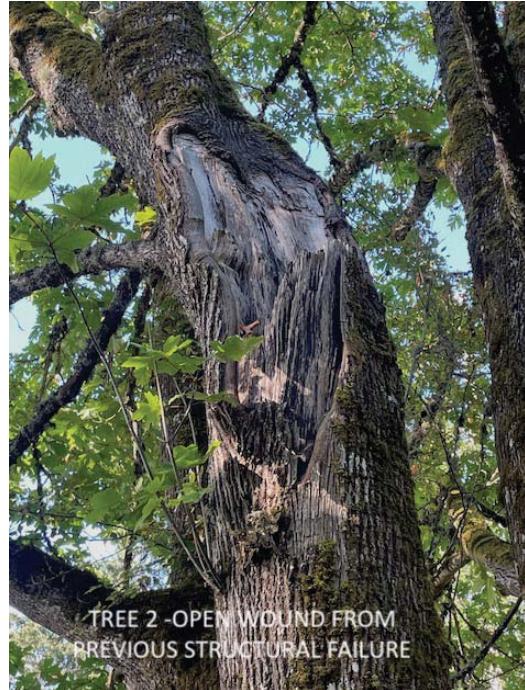
Tree No.	DBH	Species	Comments on Condition
2	13,20,24"	Bigleaf maple	Multiple leaders along trunk axis, previous leader failure and open wound with decay, included bark with response wood present
22	56"	Douglas-fir	Recent failure of the top of the tree, trunk decay visit at failure, 7.5" sound wood at base observed after extracting a wood core, scaffold branch failure in upper canopy at previous topping wound, dead hanging branch in upper canopy
63	32"	Douglas-fir	Resin oozing on lower portion of trunk, 6" sound wood from removed core, then discolored wood further in trunk, very thin foliage, some branch dieback, and suspect root rot infection.
66	33"	Douglas-fir	Previous rootplate failure and with an obvious sweep in the trunk, low LCR, thin branches throughout canopy
67	(11) 9-26"	Bigleaf maple	Multiple leaders at single attachment near grade (tree was likely cut to grade decades ago), bark inclusions present at most attachments, previous failure of structural branches, <i>Ganoderma</i> fungus fruiting bodies on lower trunk.

Tree No.	DBH	Species	Comments on Condition
2	13,20,24"	Bigleaf maple	Multiple leaders along trunk axis, previous leader failure and open wound with decay, included bark with response wood present

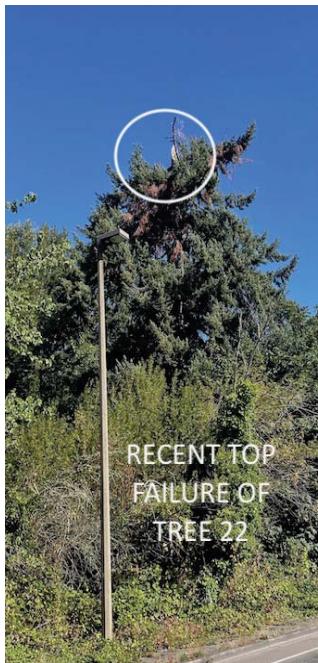
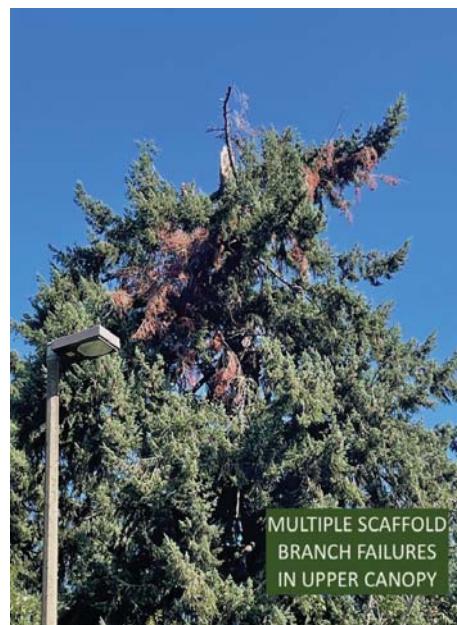
Tree No.	DBH	Species	Comments on Condition
22	56"	Douglas-fir	Recent failure of the top of the tree, trunk decay visit at failure, 7.5" sound wood at base observed after extracting a wood core (75% of radius is decayed wood), scaffold branch failure in upper canopy at previous topping wound, dead hanging branch in upper canopy

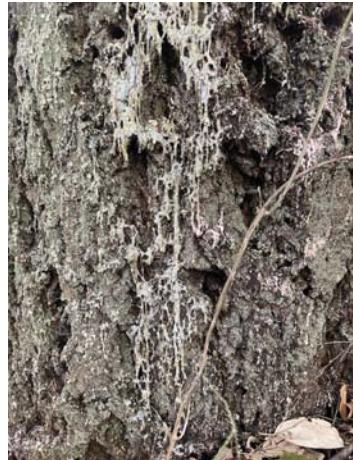
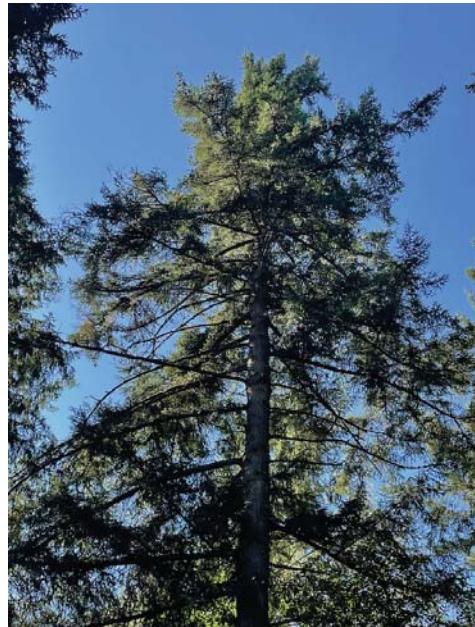
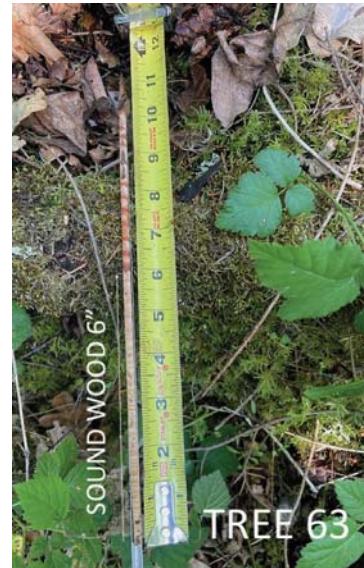
N	Onsite	Landmark	62	32"	Douglas-fir	30'				
N	Onsite	Hazard	63	35"	Douglas-fir	30'	N	N	N	Resin oozing on trunk, 6" sound wood, then discolored wood, thin foliage, some branch dieback, suspect root rot infection.
N	Onsite	Specimen	64	27"	Douglas-fir	25'				
N	Onsite	Specimen	65	25"	Douglas-fir	25'				
N	Onsite	Hazard	66	33"	Douglas-fir	35'	N	N	N	Previous rootplate failure, sweep, LCR, thin branches
N	Onsite	Hazard	67	(11) 9-26"	Bigleaf maple	45'	N	N	N	Multiple leaders, bark inclusions,

Tree No.	DBH	Species	Comments on Condition
63	32"	Douglas-fir	Resin oozing on lower portion of trunk, 6" sound wood from removed core (66% of radius is decayed wood), then discolored wood further in trunk, very thin foliage, some branch dieback, and suspect root rot infection.

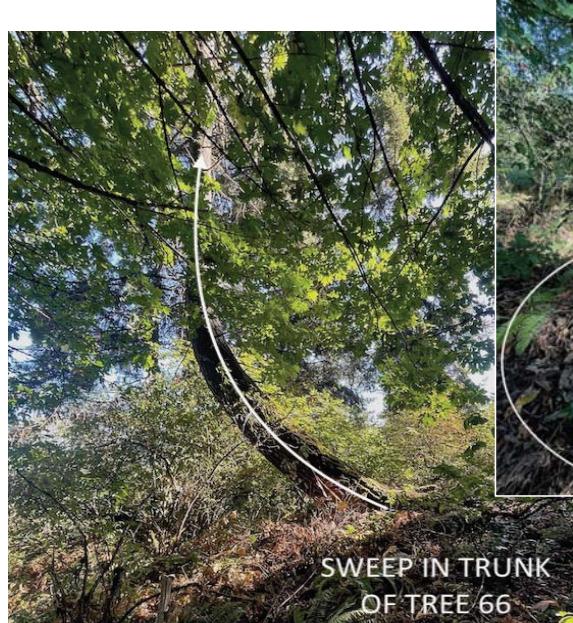
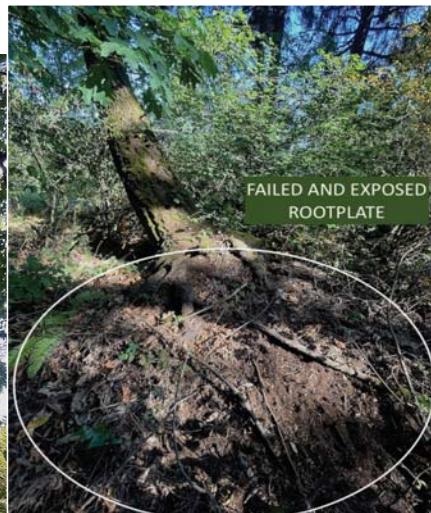
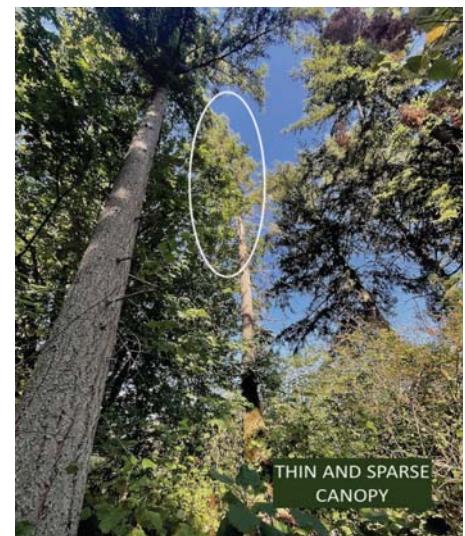
Tree No.	DBH	Species	Comments on Condition
66	33"	Douglas-fir	Previous rootplate failure and with an obvious sweep in the trunk, low LCR, thin branches throughout canopy

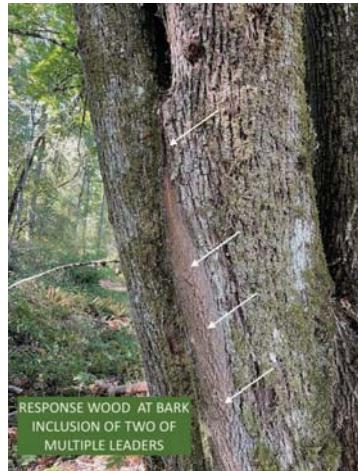
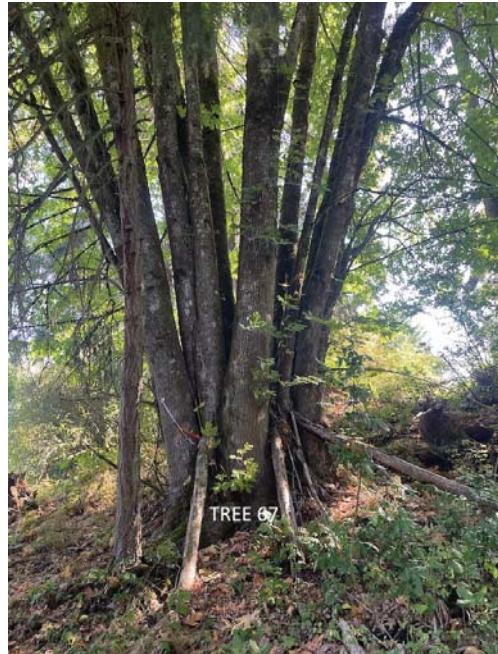
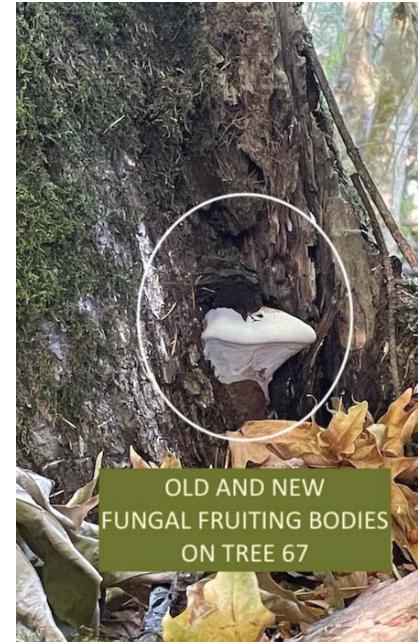
Tree No.	DBH	Species	Comments on Condition
67	(11) 9-26"	Bigleaf maple	Multiple leaders at single attachment near grade (tree was likely cut to grade decades ago), bark inclusions present at most attachments, previous failure of structural branches, <i>Ganoderma</i> fungus fruiting bodies on lower trunk.

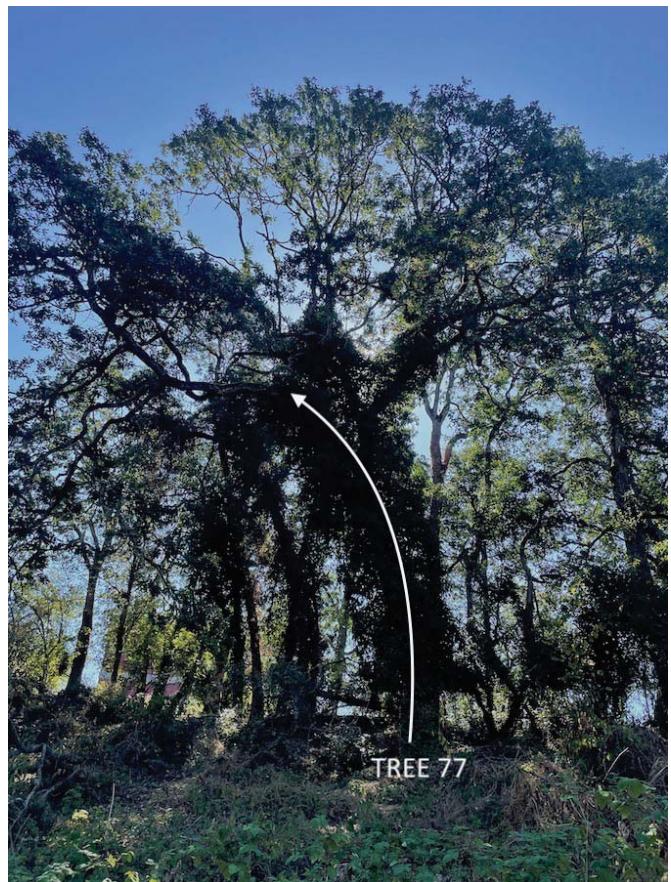
77	24"	Oregon oak	Dense ivy covering trunk, trunk leans, asymmetric structure, deadwood throughout canopy, thin branches, low LCR.

Tree No.	DBH	Species	Comments on Condition
77	24"	Oregon oak	Dense ivy covering trunk, trunk leans and with bow, asymmetric structure, deadwood throughout canopy, thin branches, low LCR.
