- Tree Retention Plan-

DuPont Industrial Warehouse Site

1700 Center Drive
DuPont, WA

Report Date: November 11, 2022

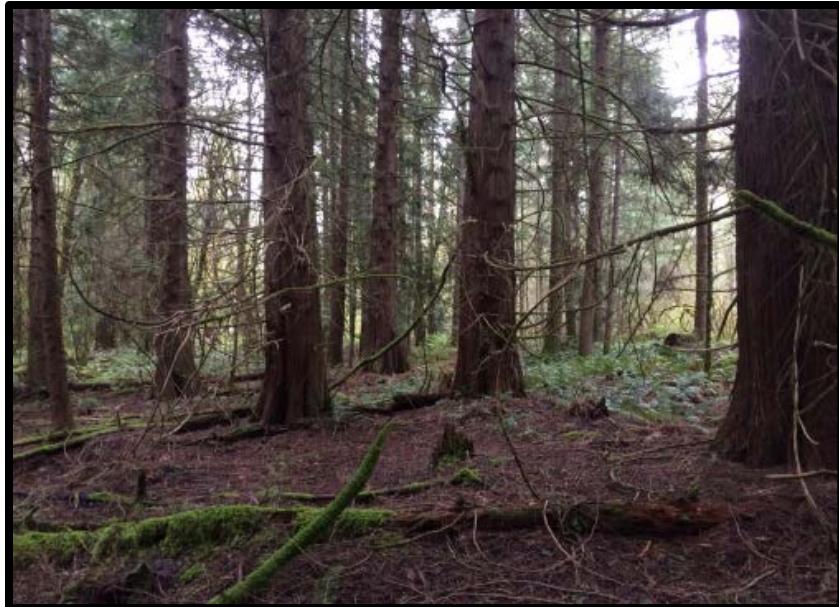
Type I. – This type is a mixed stand of deciduous and conifer trees. It covers approximately 15 acres and includes all of the Specimen, Landmark, and other trees on the site that are 4 inches and larger in diameter. There are 744 trees in this type that had their tree location surveyed. The tree species include Douglas-fir (*Pseudotsuga menziesii*), western hemlock (*Tsuga heterophylla*), western redcedar (*Thuja plicata*), Oregon white oak (*Quercus garryana*), Pacific yew (*Taxus brevifolia*), Pacific madrone (*Arbutus menziesii*), and bigleaf maple (*Acer macrophyllum*). Tree size ranges from 4 to over 50 inches DBH. Tree condition ranges from ‘Poor’ to ‘Good’, with the large majority of trees described as being in the ‘Fair’ or ‘Good’ condition class.

Photo 1: View of typical trees in Cover Type I

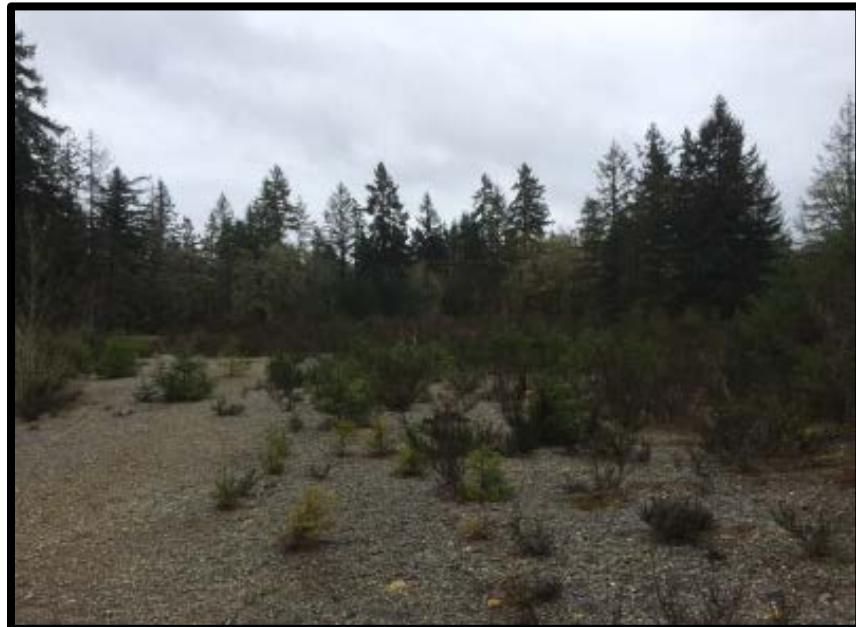
Type II. – This 10.3 acre cover type consists of mostly open, highly disturbed ground with only small thickets of young Douglas-fir trees. No trees were inventoried or surveyed in this Type. Other vegetation in this area includes abundant Scotch broom (*Cytisus scoparius*), grasses, and broadleaf weeds.

Photo 2: Non-forest - Cover Type II

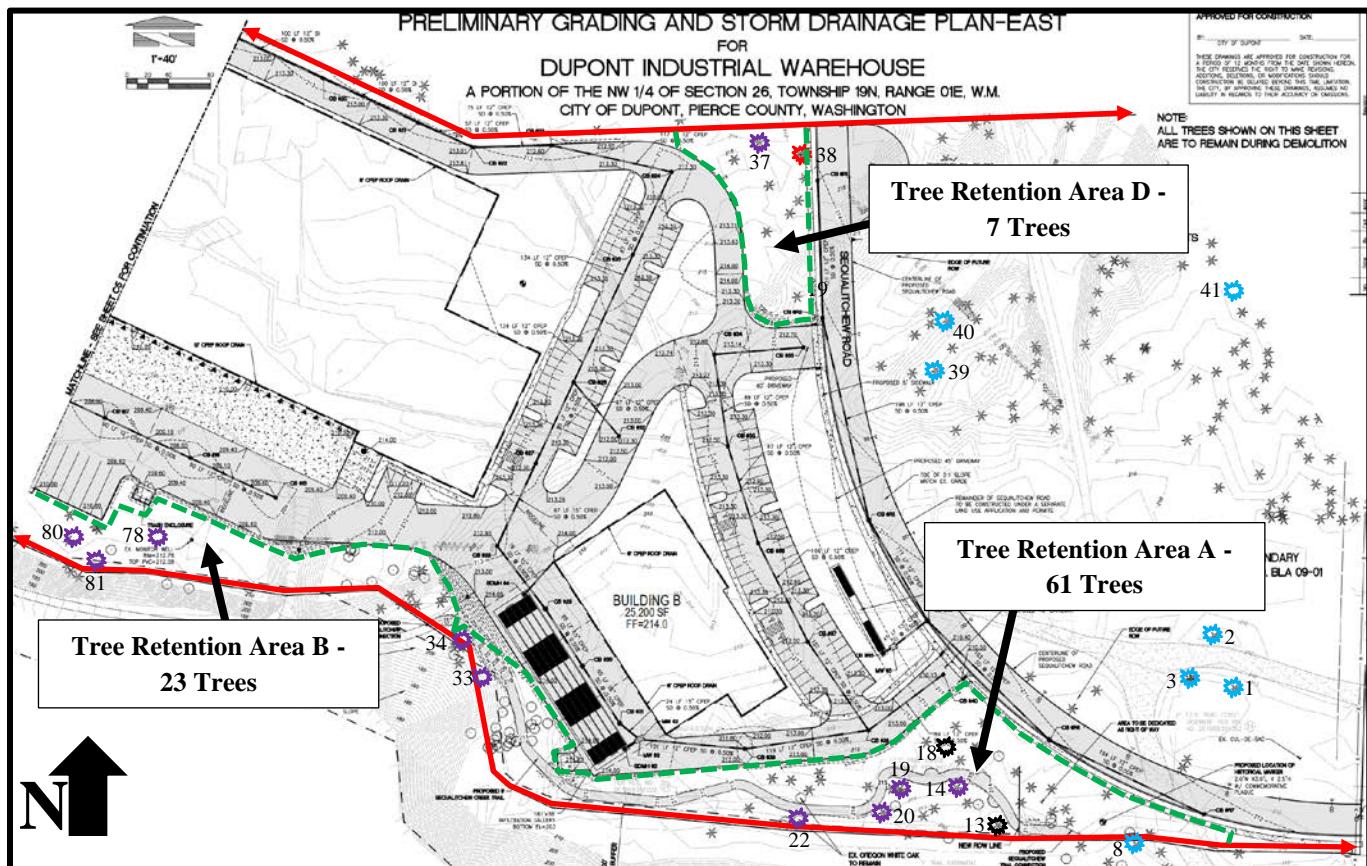
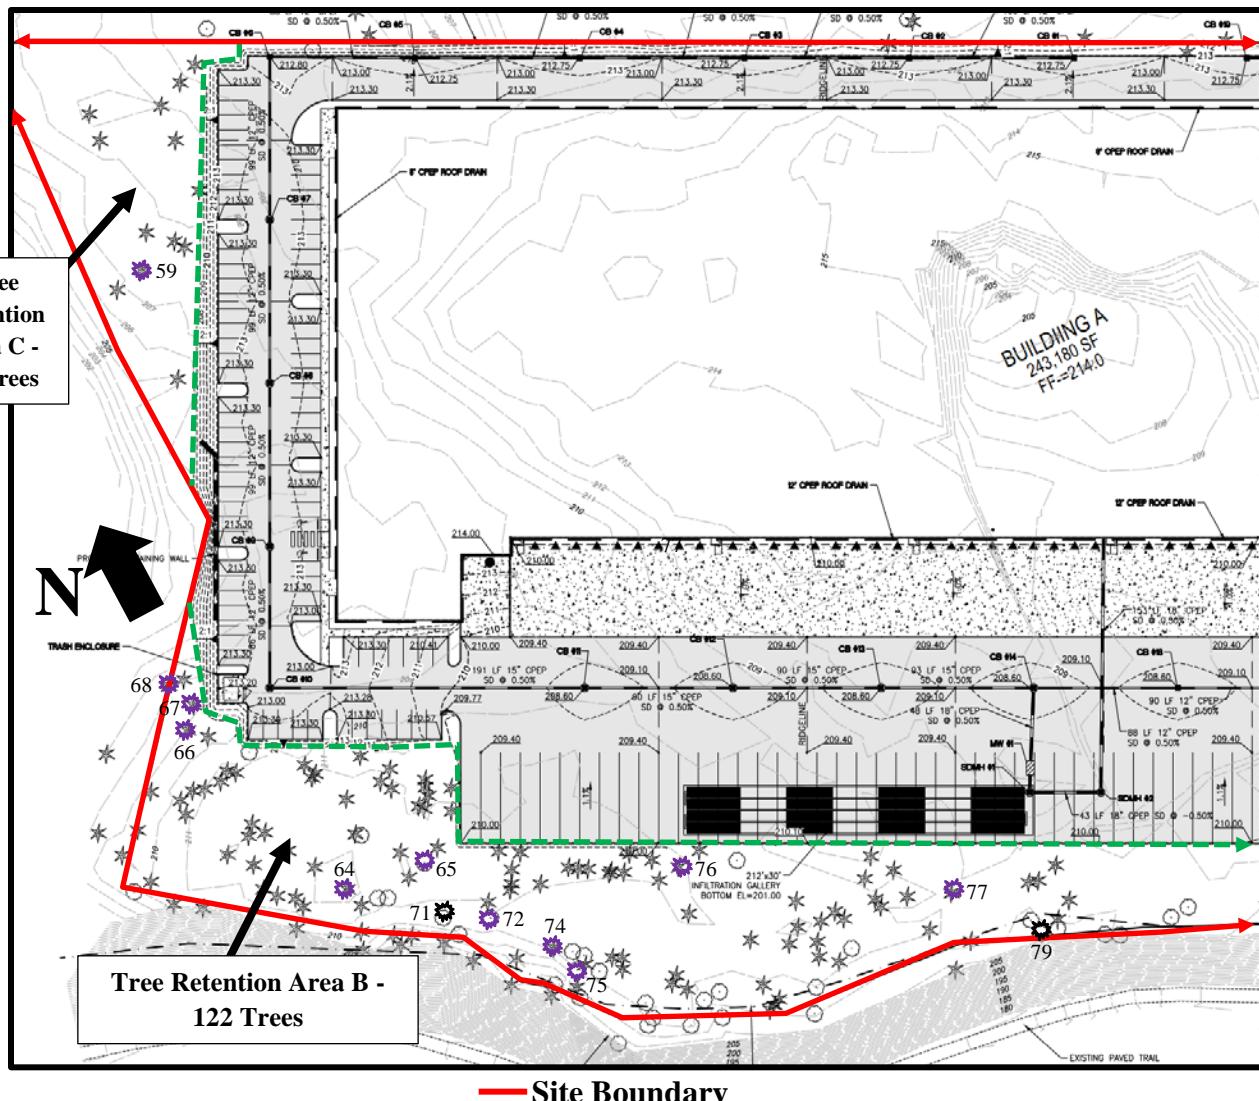
Attachment 2. Site Plan/Tree Map with Landmark Tree Locations Indicated

Locations of landmark trees are indicated on the site plan (Attachment #2). A total of **20** healthy landmark trees can be retained on the site. Fifty-six (**56**) landmark trees will need to be removed because they are either unhealthy or located under the footprint of proposed buildings, roads, storm ponds, or parking lots. Other than Oregon white oak, there is no requirement to retain these landmark trees under the footprint of the buildings, storm ponds, and parking lots, as long as tree retention is achieved in the street boundaries and abutting a residential district. All landmark trees are labeled with a blue number at the base corresponding to the table in Attachment 3.

There is an existing 42 inch Oregon White Oak tree (#12) needs to be removed due to its location in the future Y street right of way.
