- Tree Retention Plan-

DuPont Industrial Warehouse Site

1700 Center Drive
DuPont, WA

Report Date: March 1, 2023

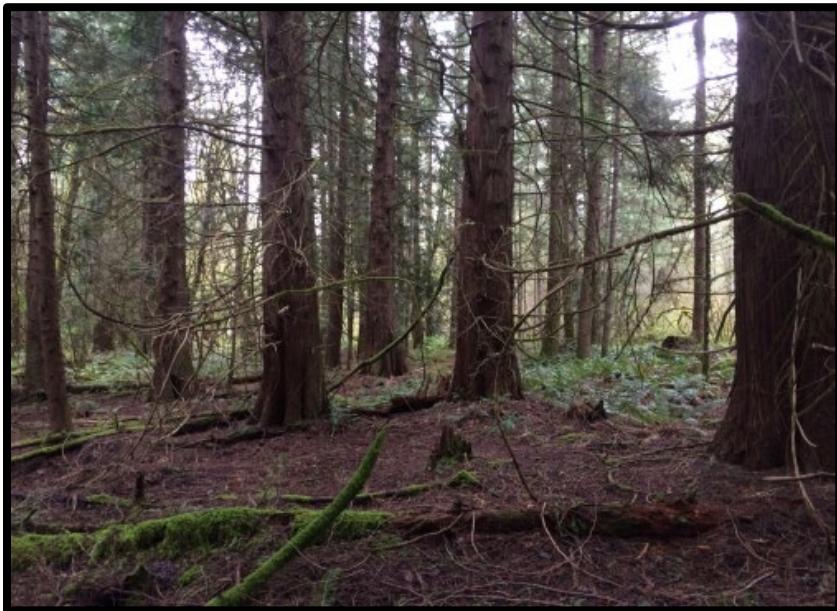
Type I. – This type is a mixed stand of deciduous and conifer trees. It covers approximately 15 acres and includes all of the Specimen, Landmark, and other trees on the site that are 4 inches and larger in diameter. There are 744 trees in this type that had their tree location surveyed. The tree species include Douglas-fir (*Pseudotsuga menziesii*), western hemlock (*Tsuga heterophylla*), western redcedar (*Thuja plicata*), Oregon white oak (*Quercus garryana*), Pacific yew (*Taxus brevifolia*), Pacific madrone (*Arbutus menziesii*), and bigleaf maple (*Acer macrophyllum*). Tree size ranges from 4 to over 50 inches DBH. Tree condition ranges from ‘Poor’ to ‘Good’, with the large majority of trees described as being in the ‘Fair’ or ‘Good’ condition class. Table 1 is a summary of trees located on the project site. A complete list of Landmark trees located on-site is found in Attachment 3.

Photo 1: View of typical trees in Cover Type I

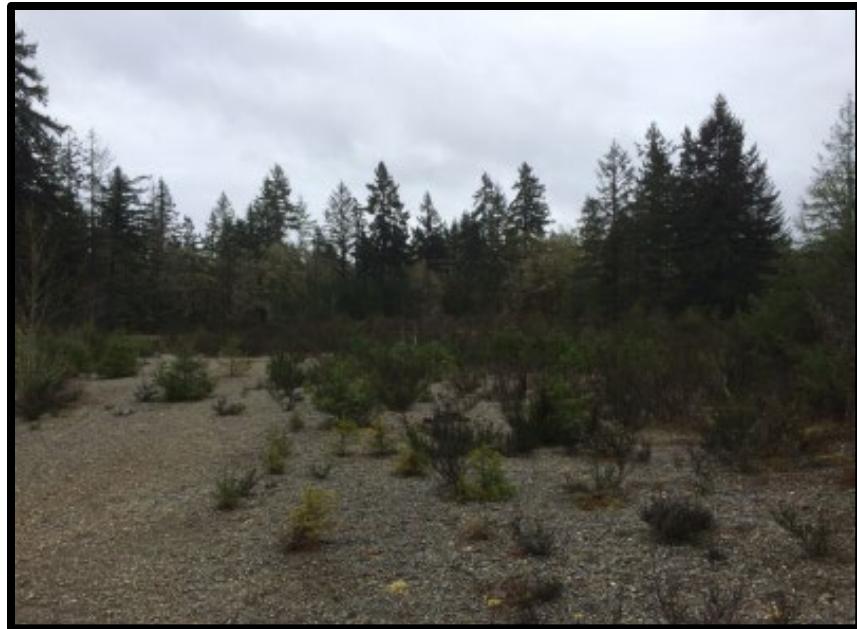
Type II. – This 10.3 acre cover type consists of mostly open, highly disturbed ground with only small thickets of young Douglas-fir trees. No trees were inventoried or surveyed in this Type. Other vegetation in this area includes abundant Scotch broom (*Cytisus scoparius*), grasses, and broadleaf weeds.

Photo 2: Non-forest Cover Type II

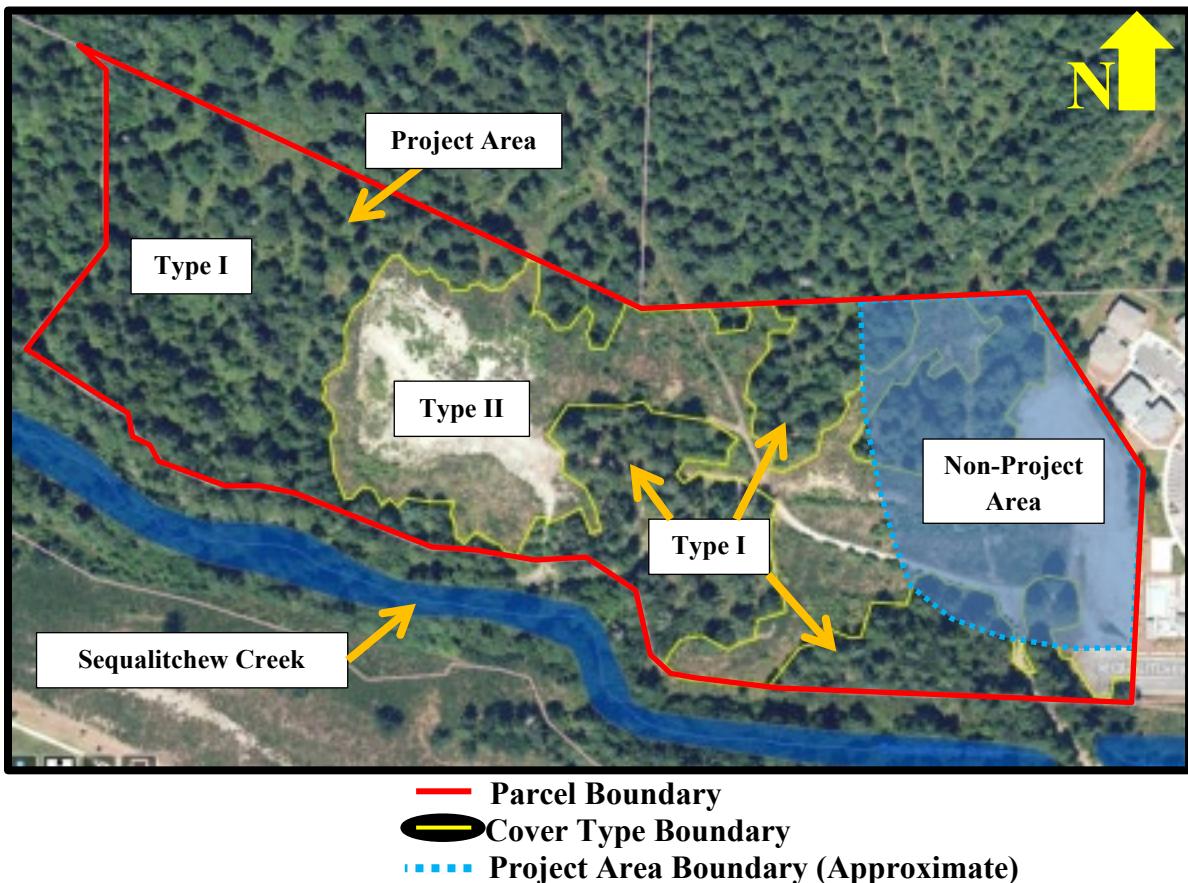
Attachment 1. Aerial Photo of DuPont Industrial Warehouse with Cover Types Labeled

There are 2 cover types on this 25.29 acre parcel for the purposes of description. Type I was forested and Type II is non-forest brush land (see Attachment #1). We found and evaluated a total of 744 trees in the project area. Most of the trees were considered to be healthy, long-term trees if they were saved. The following is a description of the forest cover types:

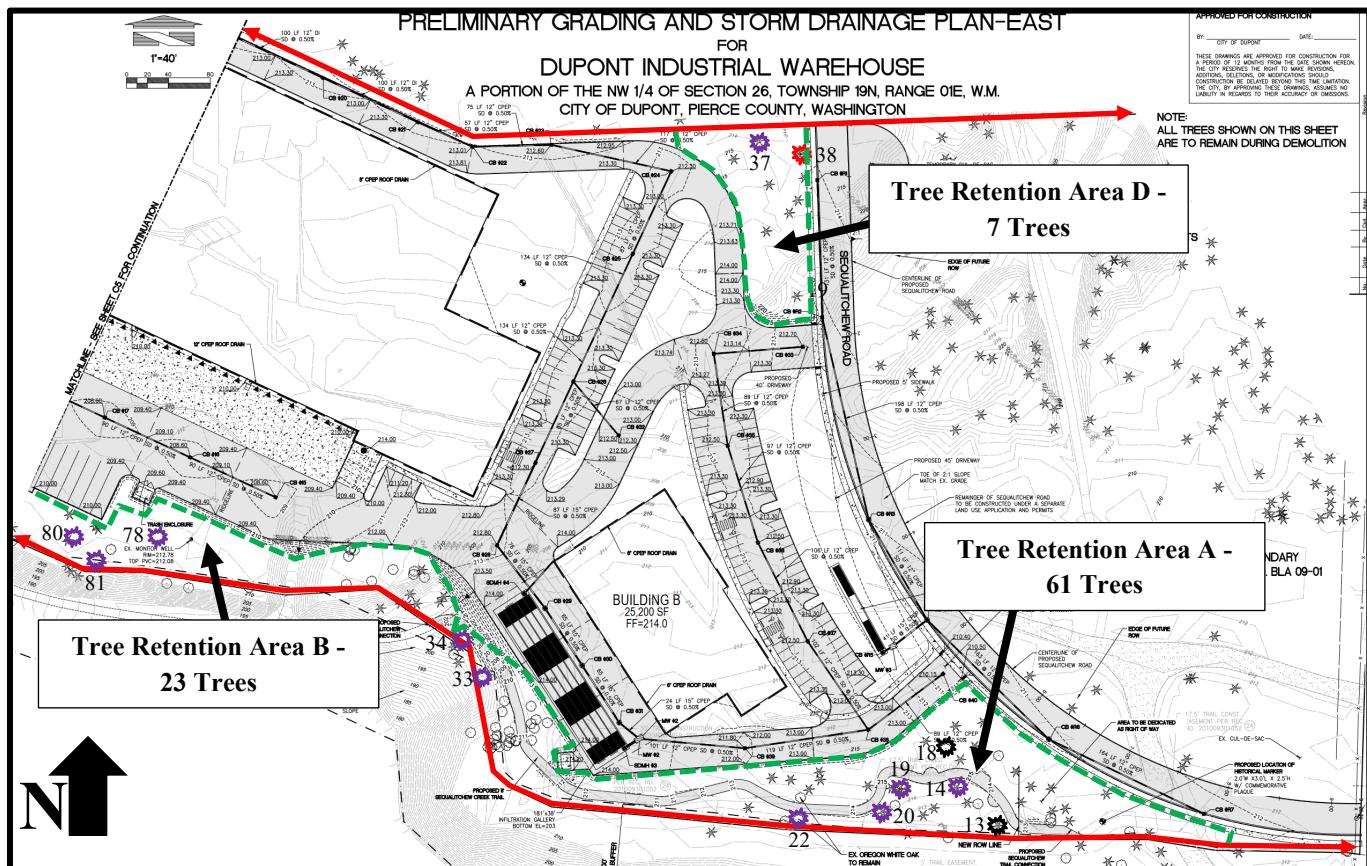
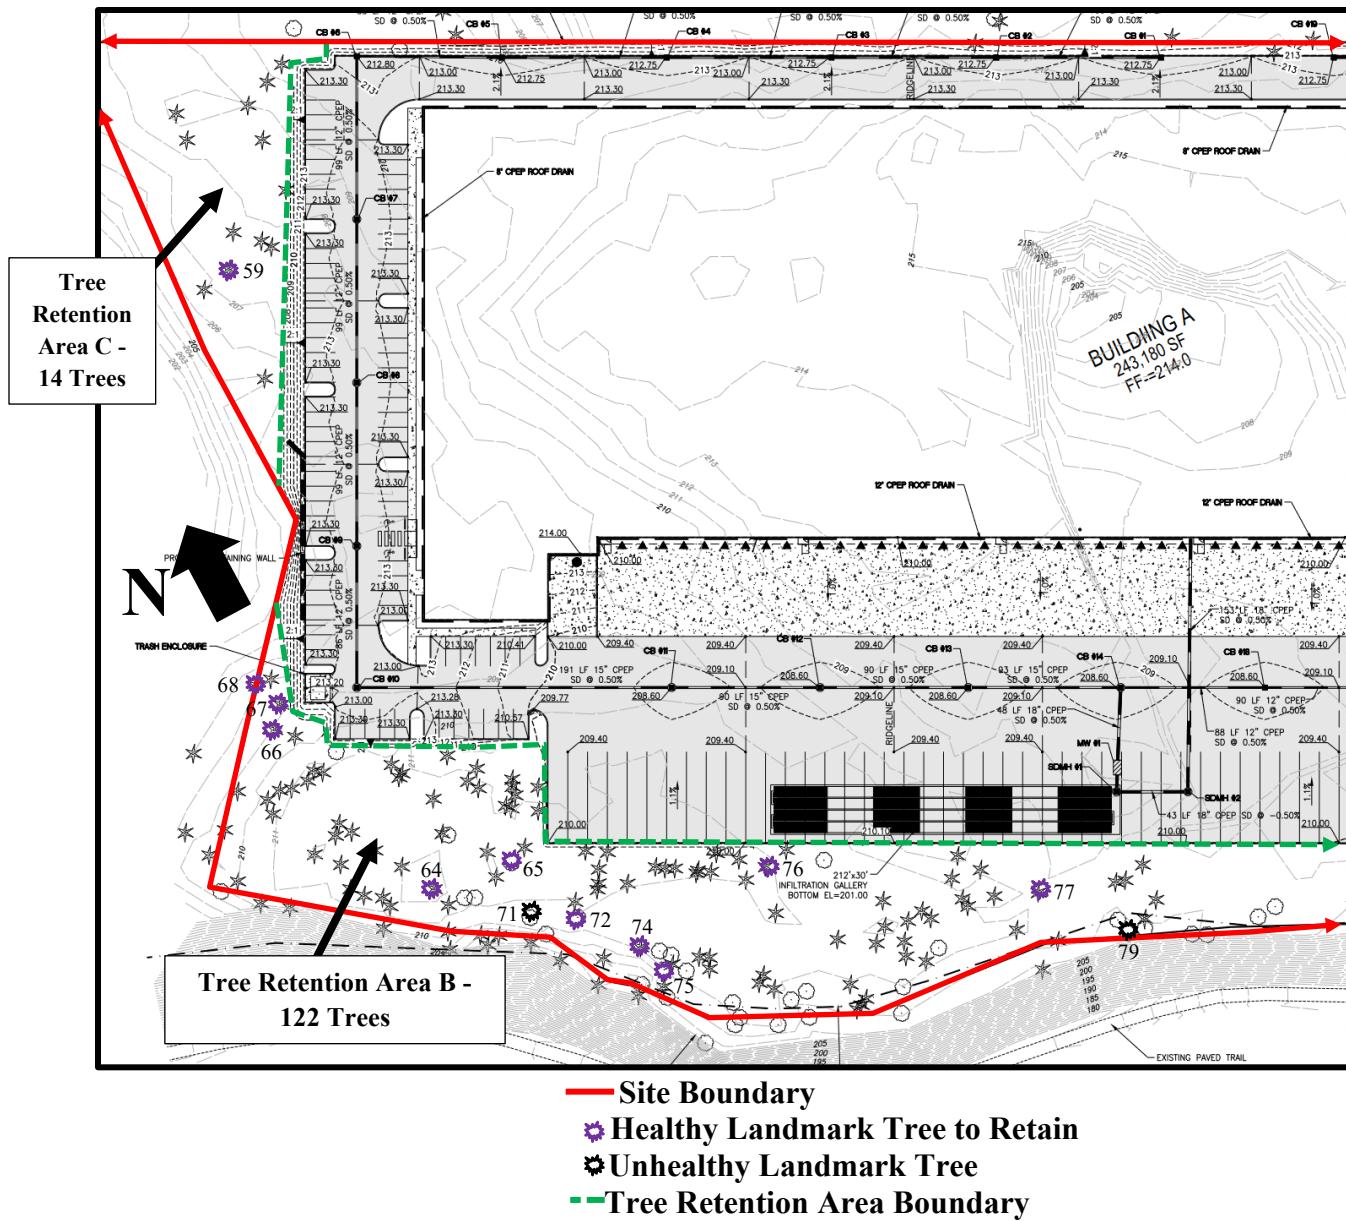
Attachment 2. Site Plan/Tree Map with Landmark Tree Locations Indicated

Locations of landmark trees are indicated on the site plan (Attachment #2). A total of **21** healthy landmark trees can be retained on the site. Fifty-four (**54**) landmark trees will need to be removed because they are either unhealthy or located under the footprint of proposed buildings, roads, storm ponds, or parking lots. Other than Oregon white oak, there is no requirement to retain these landmark trees under the footprint of the buildings, storm ponds, and parking lots, as long as tree retention is achieved in the street boundaries and abutting a residential district. All landmark trees are labeled with a blue number at the base corresponding to the table in Attachment 3.
