- Tree Retention Plan-

DuPont West

1700 Center Drive
DuPont, WA

Report Date: March 20, 2024

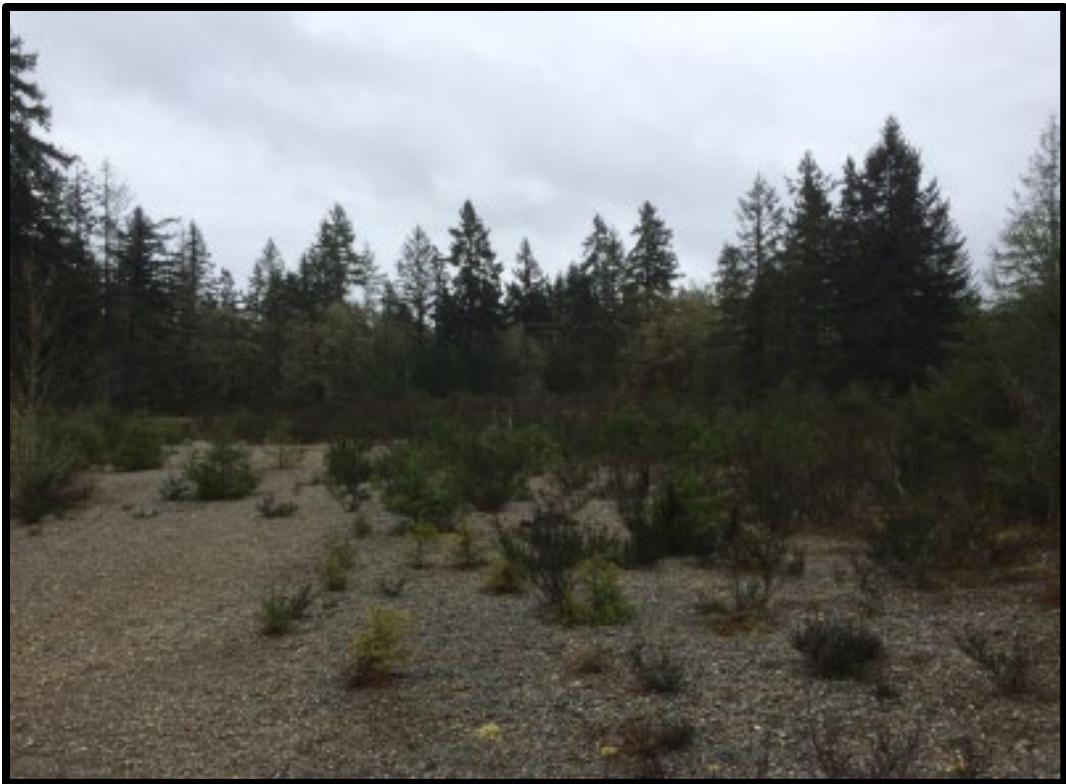
Type II. – This 6.10-acre cover type consists of mostly open, highly disturbed ground with only small thickets of young Douglas-fir trees. No trees were inventoried or surveyed in this Type. Other vegetation in this area includes abundant Scotch broom (*Cytisus scoparius*), grasses, and broadleaf weeds.

Photo 2: Non-forest Cover Type II

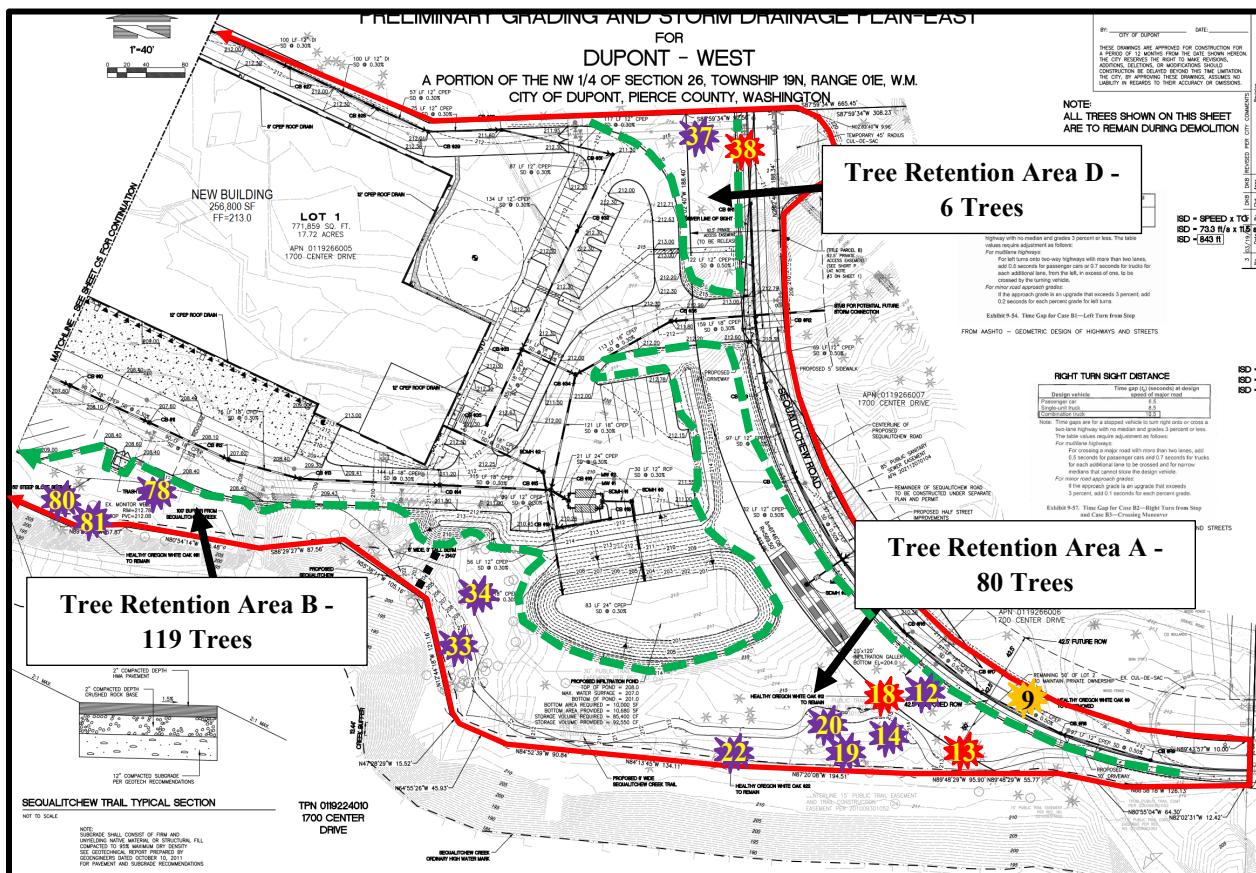
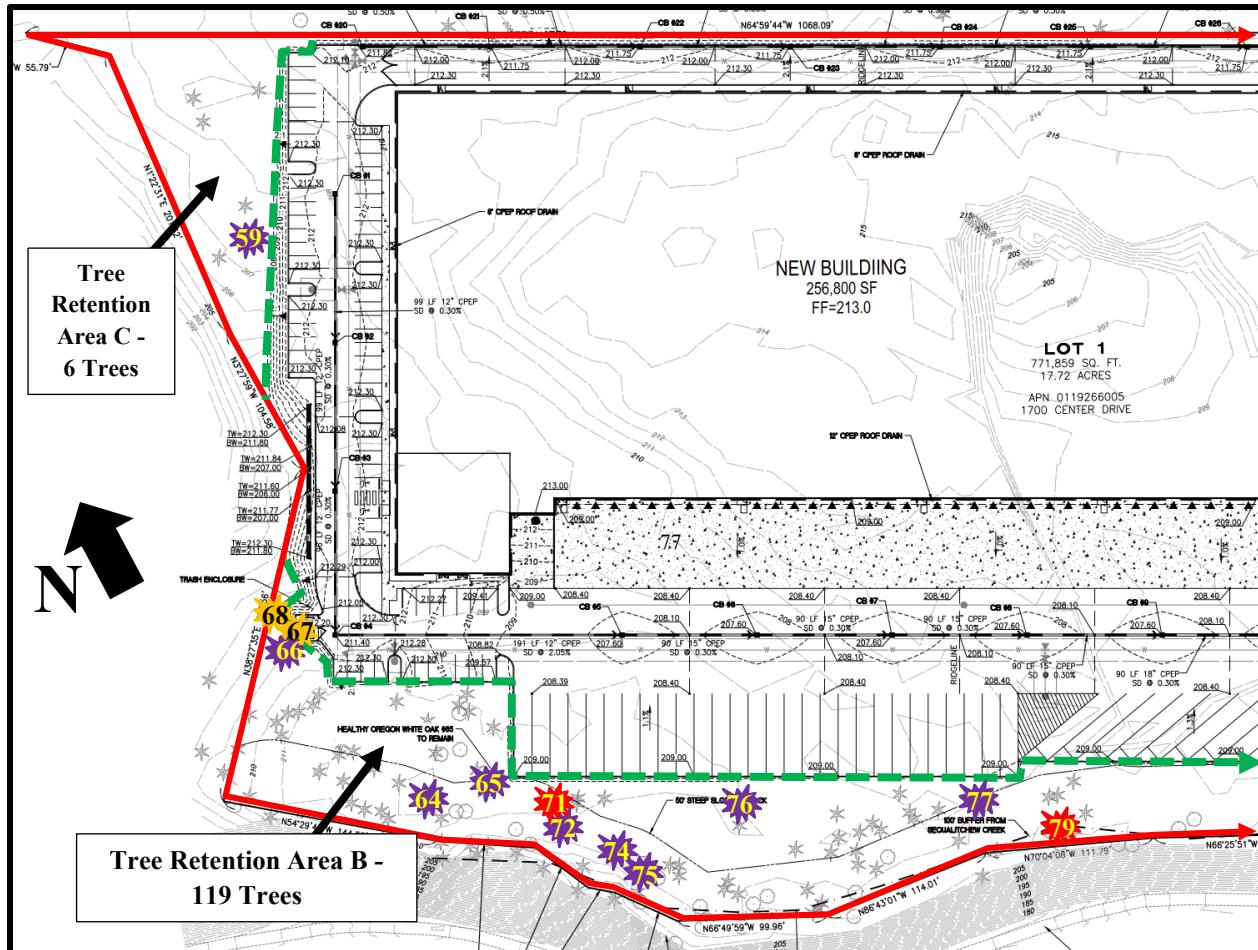
Attachment 2. DuPont West Site Plan/Tree Map with Landmark Tree Locations Indicated

Locations of landmark trees are indicated on the site plan (Attachment #2). A total of **19** healthy landmark trees can be retained on the site. Fifty-six (**56**) landmark trees will need to be removed because they are either unhealthy or located under the footprint of proposed buildings, roads, storm ponds, or parking lots. Other than Oregon white oak, there is no requirement to retain these landmark trees under the footprint of the buildings, storm ponds, and parking lots, as long as tree retention is achieved in the street boundaries and abutting a residential district. All landmark trees are labeled with a blue number at the base corresponding to the table in Attachment 3.
