- Tree Assessment -

## SESQUALITCHEW CREEK RESTORATION

Prepared for: Anchor QEA

Date of Report: March 6, 2023

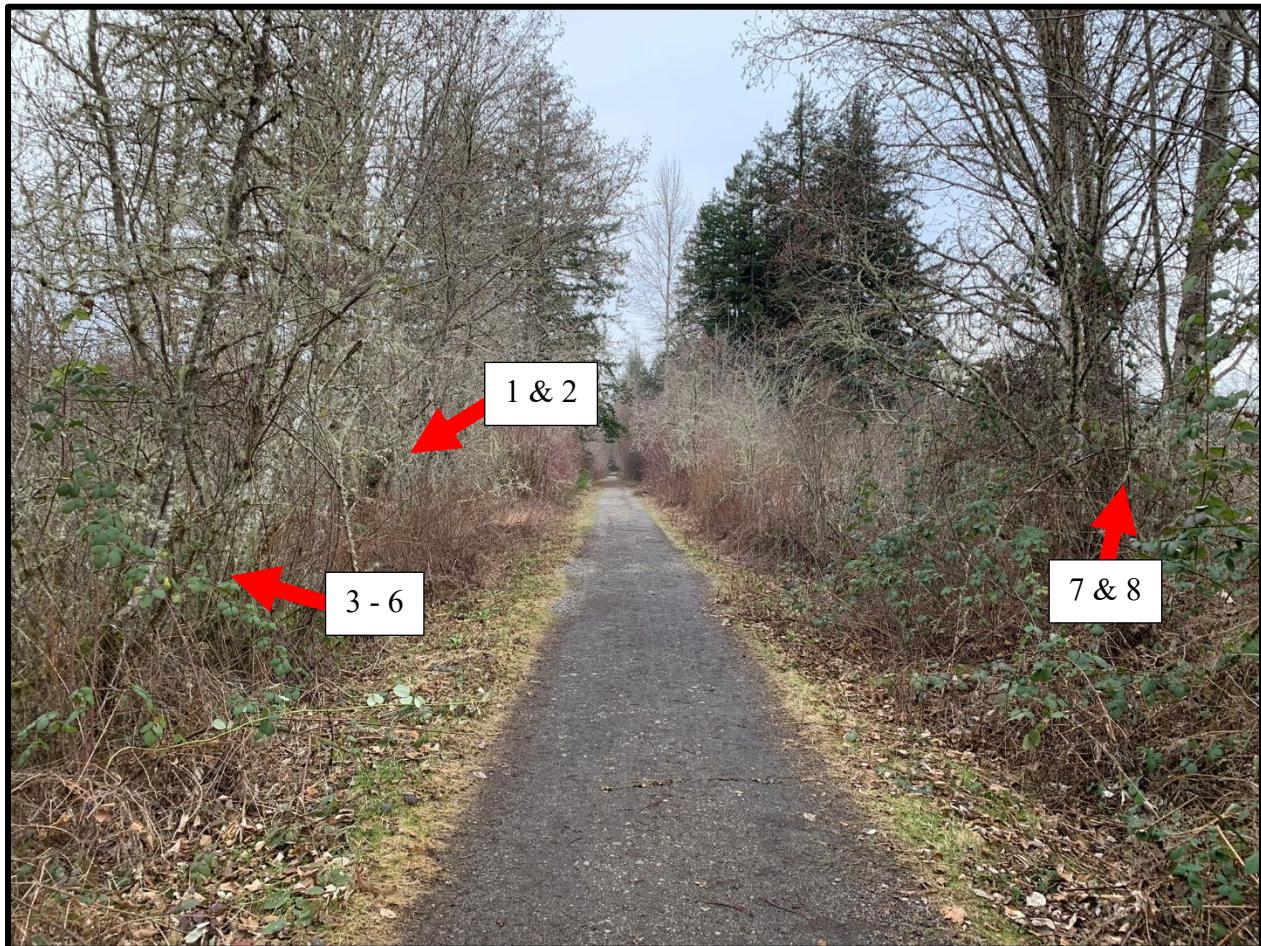
The trees in this area are all red alder (*Alnus rubra*) growing along the sides of the grade. The tree diameters range in size from 6 to 26 inches in DBH. Tree conditions are mostly 'Fair' with one tree in 'Poor' condition. Tree locations are shown on the site plan in Attachment 1. The growth structure of the trees is stunted because of the poor, wet soils and lots of branches due limited photosynthetic competition from surrounding trees.

The soil removal for the project will damage the root systems of all 8 assessed trees. They will all need to be removed to complete the project. The removed trees will be used to improve fish habitat in Sequalitchew Creek downstream of Edmond Marsh. Branches from overhanging trees approaching the site will need pruning to allow access for the construction equipment.

**Photo A. View of tree removal trees at Robison Trail Bridge Site.**

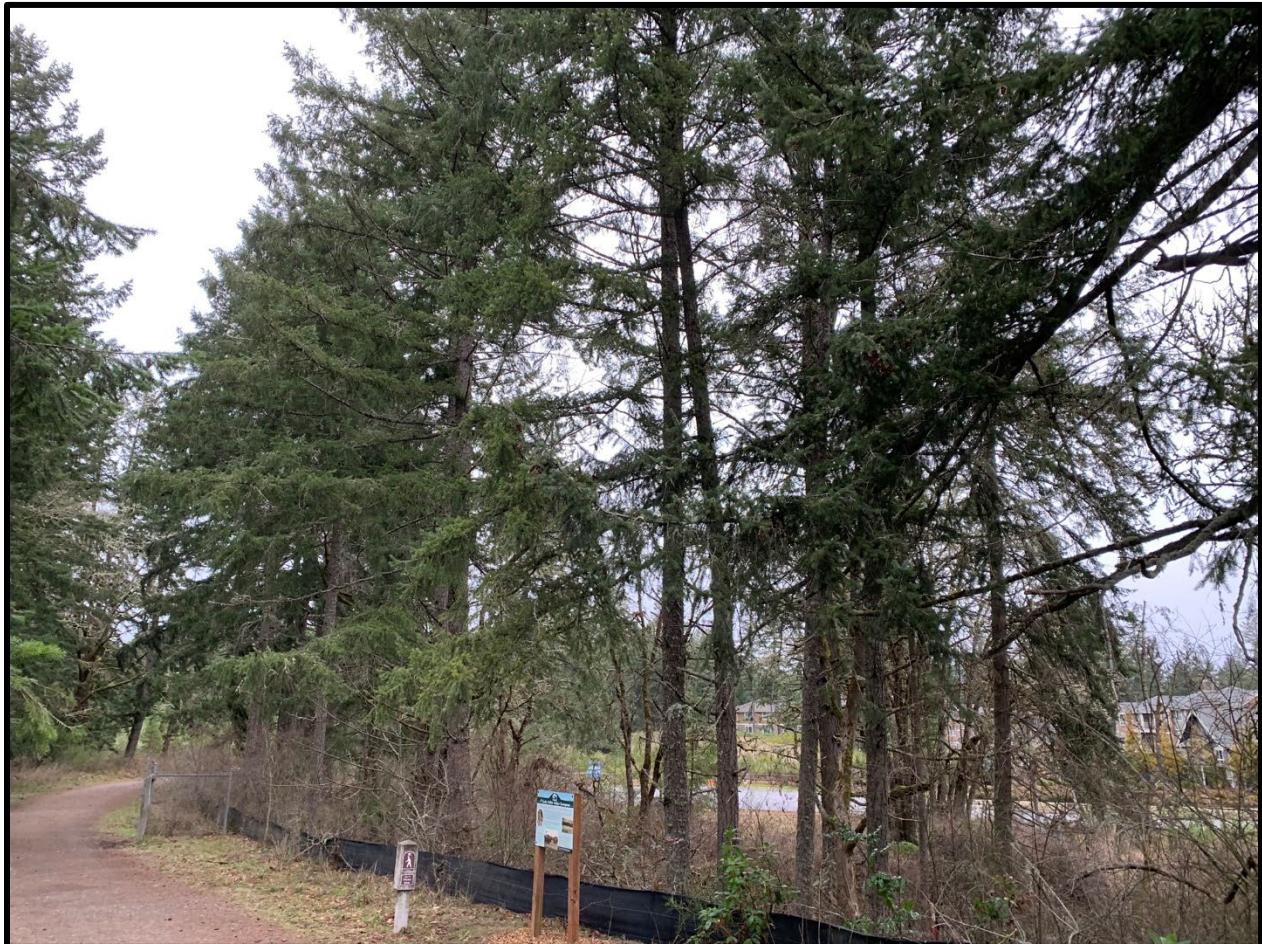
There were 37 trees identified as being impacted by the proposed work. Tree species in this area are Douglas-fir (*Pseudotsuga menziesii*), black cottonwood, Oregon white oak, bigleaf maple (*Acer macrophyllum*), Oregon ash (*Fraxinus latifolia*), and red oak (*Quercus rubra*) growing along the sides and in the streambed of Sequalitchew Creek. The tree diameters range in size from 8 to 55 inches in DBH. All but five trees are suitable for retention based on tree health. There are four Oregon white oak trees that will be removed for the project. Two of the white oak trees are considered a 'Significant' tree, over 12" DBH. The other two trees are 10" DBH. Tree locations are shown on the site plan in Attachment 3.

The soil removal and grading for the project will damage the root systems of up to 35 assessed trees and will require removal to complete the project. Removed trees will be used to improve fish habitat in this reach of Sequalitchew Creek. Two trees outside of the project boundaries will be impacted but can be retained.

**Photo B. View trees to be removed at the City Hall Culvert Removal/Pedestrian Bridge Site.**
