# Exhibit 3.c

## Geotechnical Soil Observation Report

| <b>Project Name</b><br>Champion Centre<br>Geotechnical Soil Observation Report | | <b>Job #</b><br>12895 | <b>Inspection Report #1</b> |
| <b>Address / Parcel No.</b><br>XXX Steilacoom Dupont RD SW / 0119362043 | | <b>Date</b><br>August 24, 2023 | <b>Page</b><br>1 of 11 |

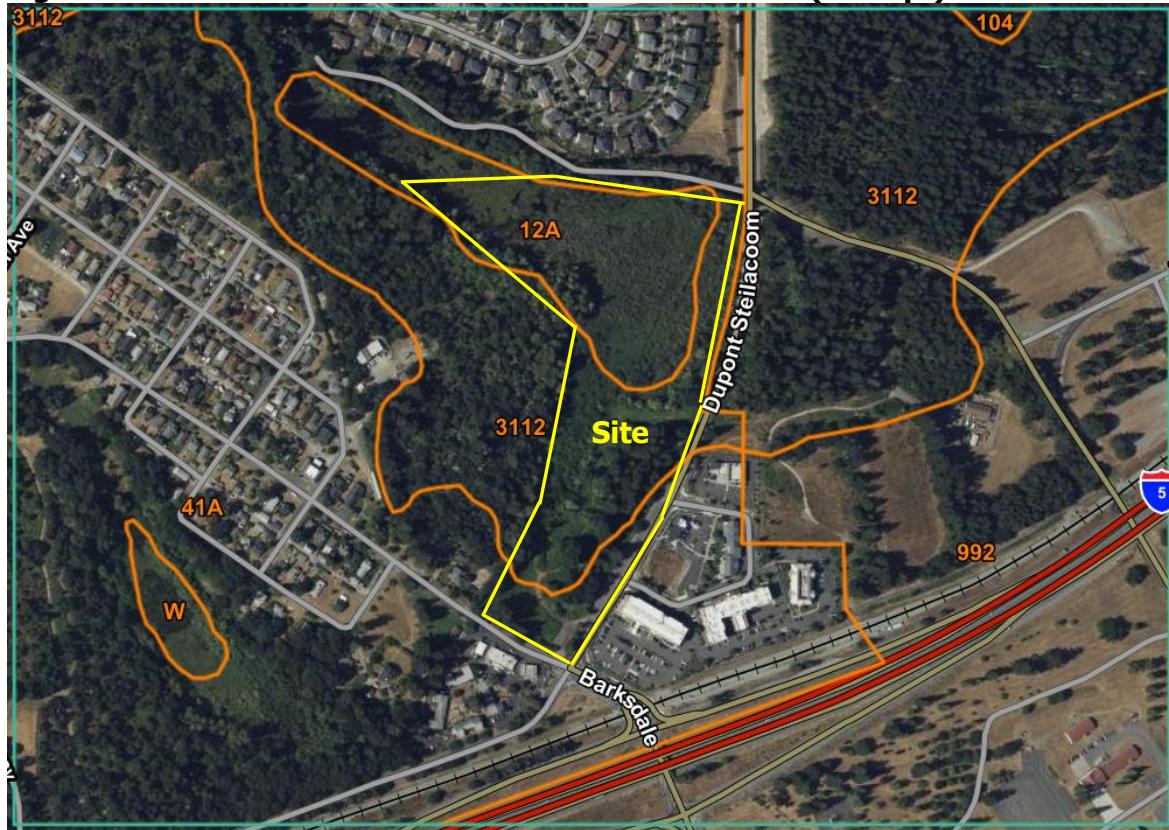
**Figure 1: Site Position within NRCS Soil Environments (Excerpt)**

According to the NRCS, the site is situated over three soil environments. However, most of the proposed development area is situated on the Spanaway gravelly sandy loam, while a small portion may extend over a transition to the Everett-Spanaway-Spana Complex. Figure 1 illustrates the site position in the soil mapping.

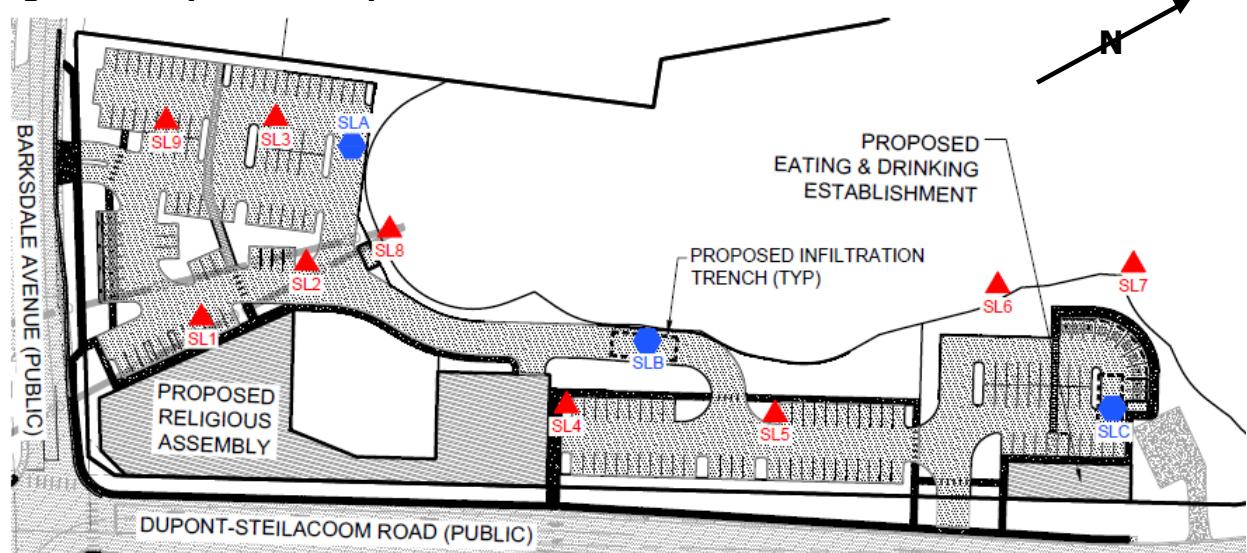
**Figure 2: Proposed Champion Center with Test Pit Locations**

Based on our test pits we can confirm the NRCS soil mapping on the site. We confirmed the site development area to be situated wholly or mostly on the Spanaway gravelly sandy loam. Figure 2 illustrates the site test pit locations on the site development plans.

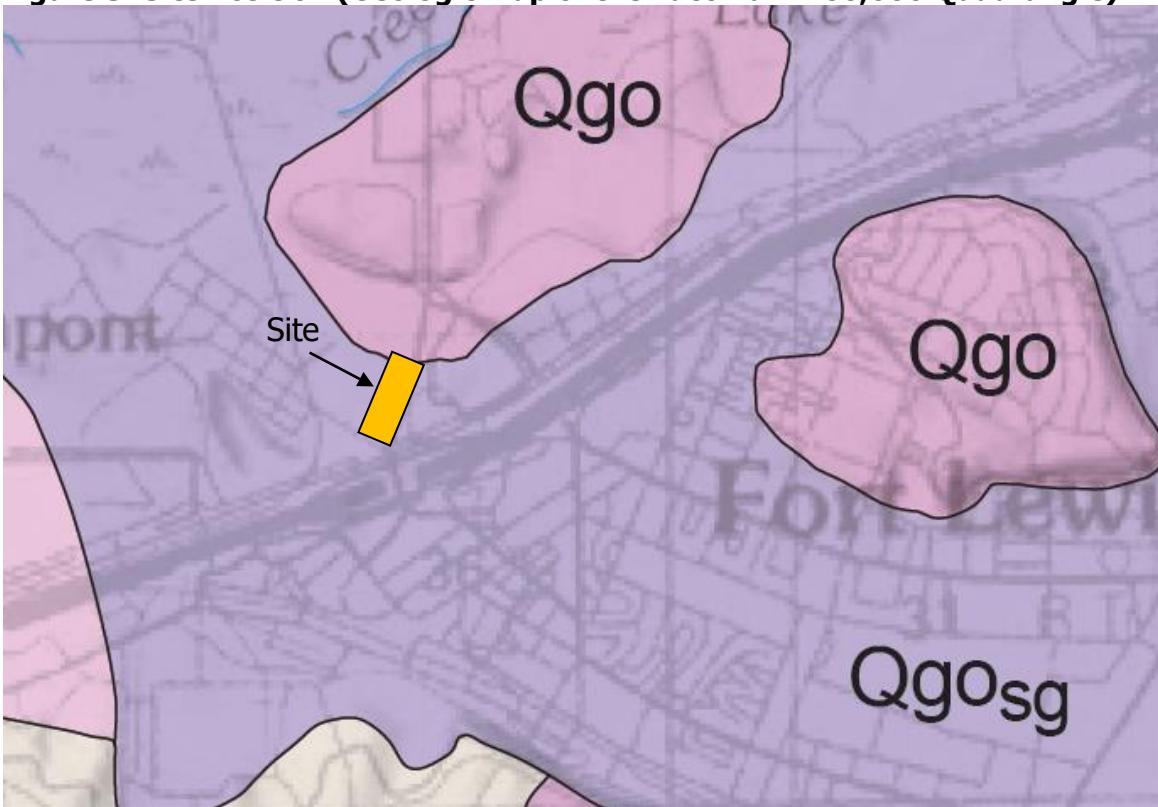
**Figure 3: Site Position (Geologic Map of the Tacoma 1:100,000 Quadrangle)**

According to the Geologic Map of the Tacoma 1:100,000-scale Quadrangle, Washington, in Figure 3 below; this site is located on a coarse glacial outwash deposit emplaced during a period of glacial lake outburst flooding during the end of the Fraser glaciation period. A large regional body of water trapped between glacial ice in the lowlands, and the Cascade foothills to the east was released suddenly through ice failure. This catastrophic event produced a large scale erosion event which eroded and removed the previously emplaced glacial stratigraphy throughout the Spanaway and Lakewood area, and replaced the original material in the basin with an excessively coarse outwash referred to as the Steilacoom gravel (Qgo<sub>sg</sub>).

Ice blocks were transported and deposited in the terrain during this outburst flooding. Kettle formations, found throughout the broad Steilacoom Gravel deposit, were created by these large ice blocks that were left behind by the retreating glacier. Sediment was deposited around the ice blocks, leaving kettle lakes when the ice melted. This event also deposited mounds of outwash against ice blocks present on the surface, that (following melting); left 'Kame' features (isolated mounds of gravel outwash). Spanaway Lake, Gravelly Lake, and nearby Old Fort Lake are well-known examples of kettles. The mounds and knob features in the area represent these outwash gravel kames. Figure 3 illustrates the site's position in the local geology.

**Recessional outwash, Steilacoom Gravel**—Pebbles with boulders; local crossbedding; kettles and other ice-contact depressions.

As discussed in the 'Geology' section above, the localized 'knobs' or 'mounds' are Kame features. The kames are composed of the coarse recessional flood outwash that was trapped at the time between glacial ice sheet remnants. These ice sheet blocks came to rest during the flooding on the surface where outwash became deposited against them. Upon melting, the outwash gained the appearance they have today as a mounded feature.

These deposits do not have inclined geologic contacts with permeable sediment overlying impermeable sediment, nor are any springs present per our observations (nor would they be possible in this geology). The 15% slope angle and its similar call out in other jurisdictions is only intended to warrant further analysis. In no case is such a shallow slope angle unstable. The typical angle of repose (the maximum angle an unconsolidated aggregate remains stable) for clean, well sorted, semi-rounded sand is 60 to 70 percent. The aggregate on this site has a steeper angle of repose given the poor sorting and minor sub-rounding form of the aggregate. The slope is globally stable in our opinion.

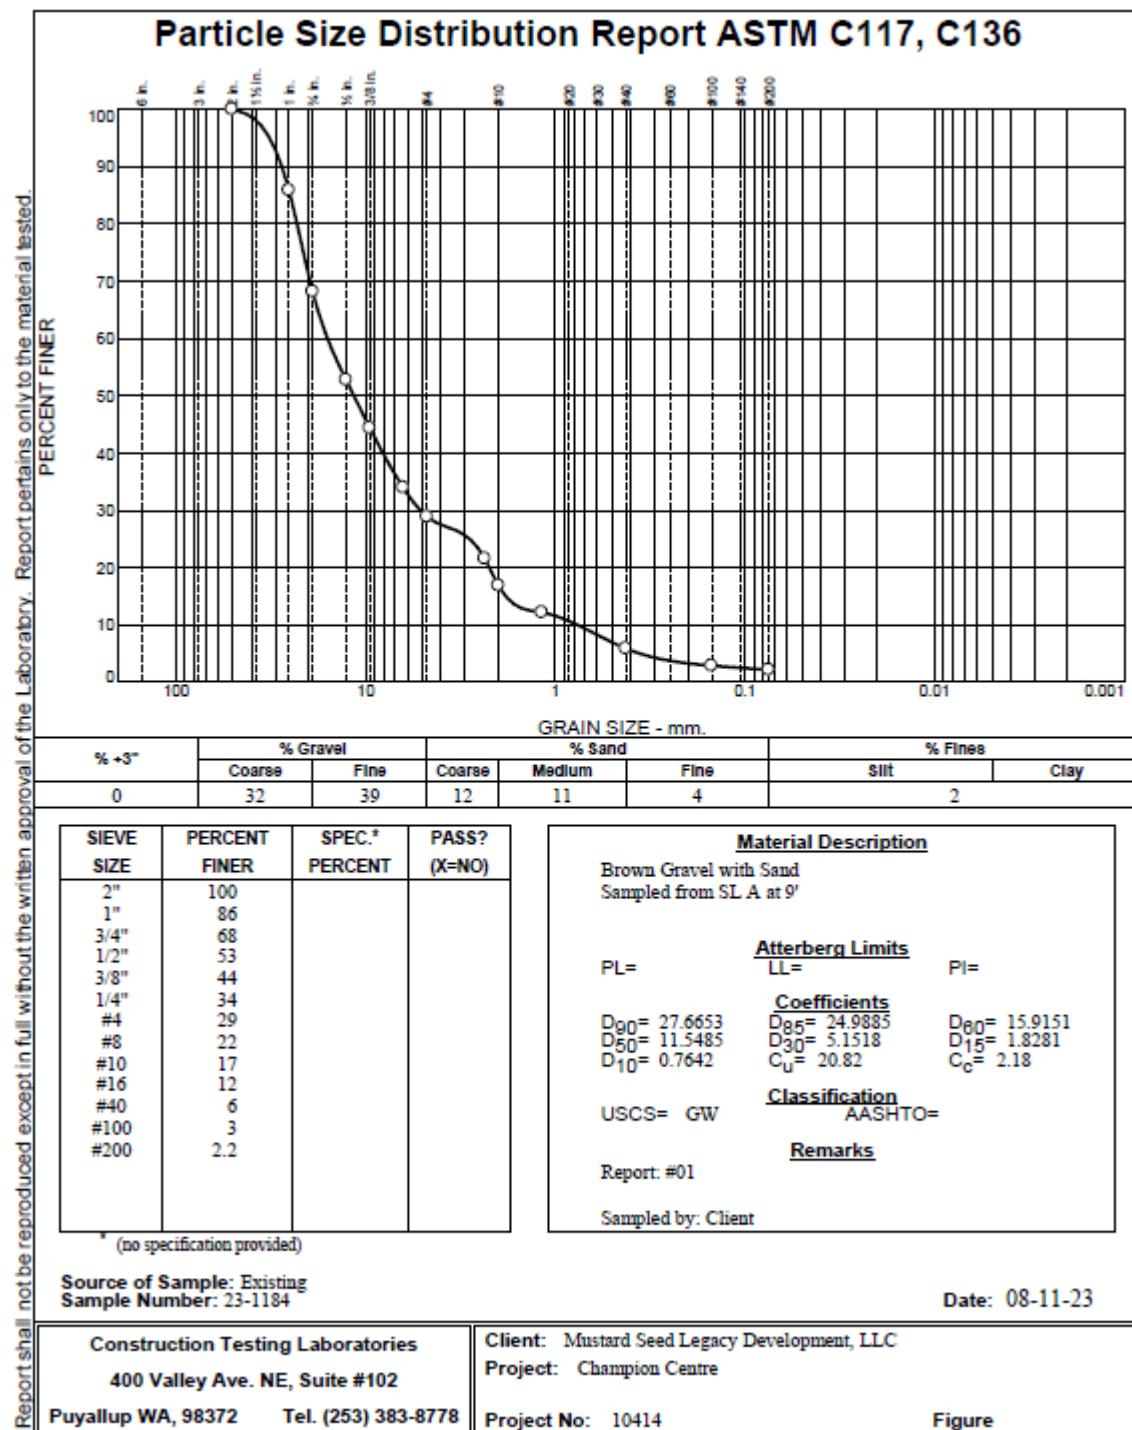
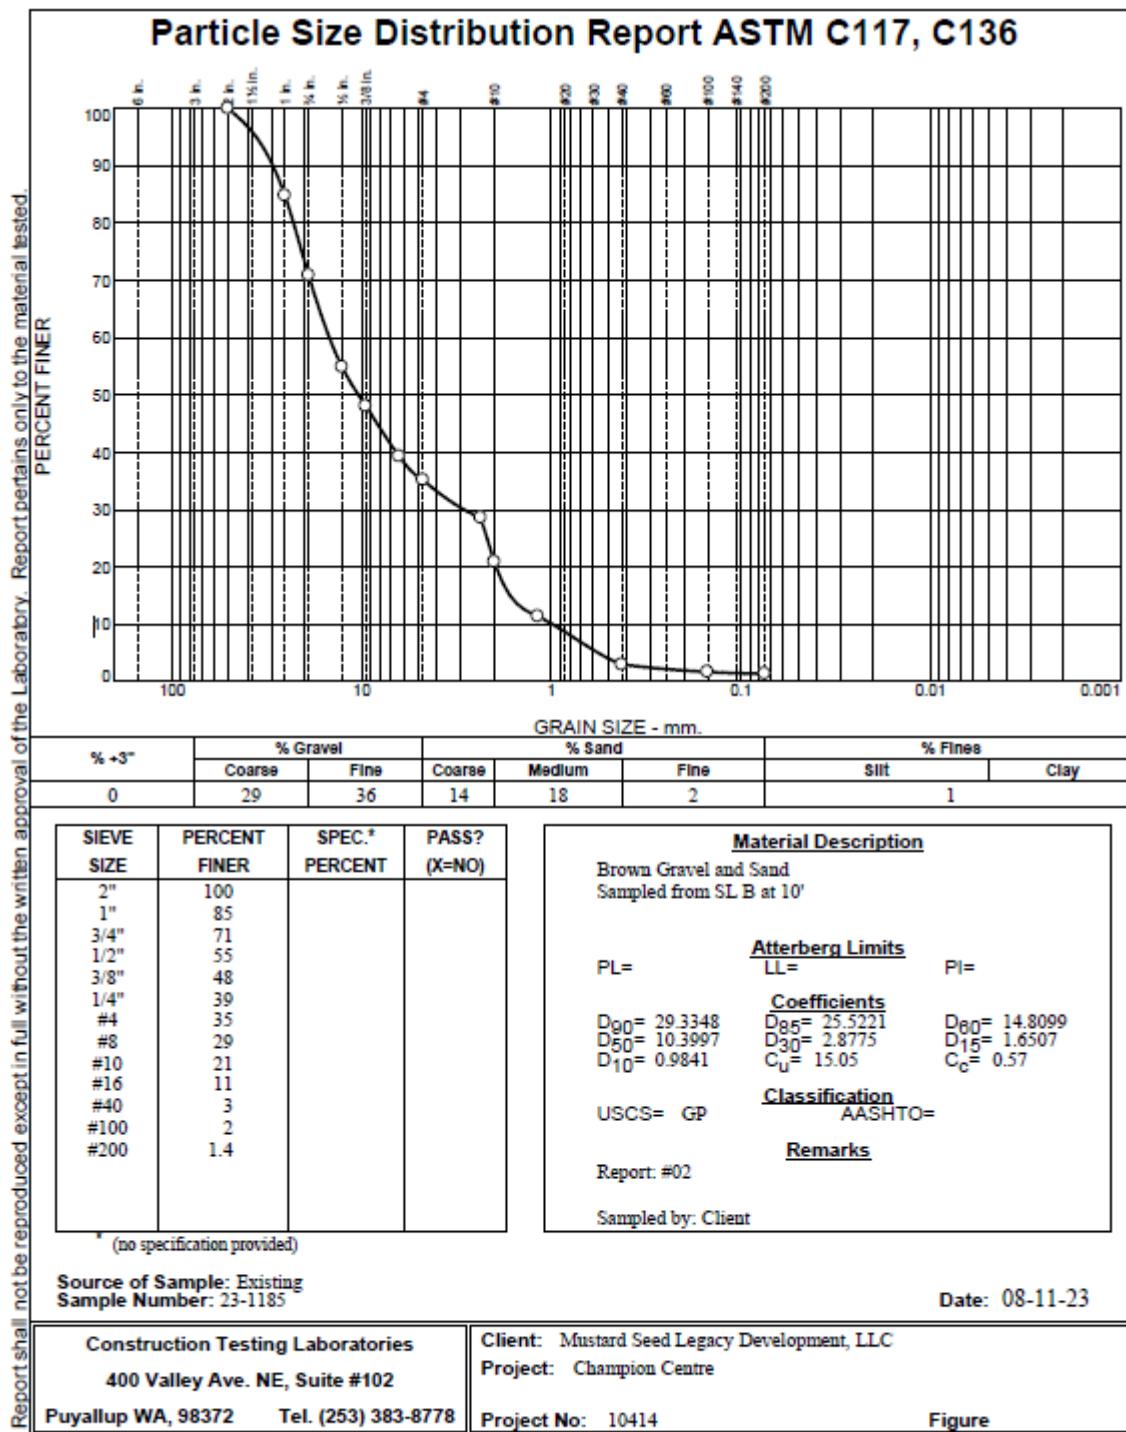
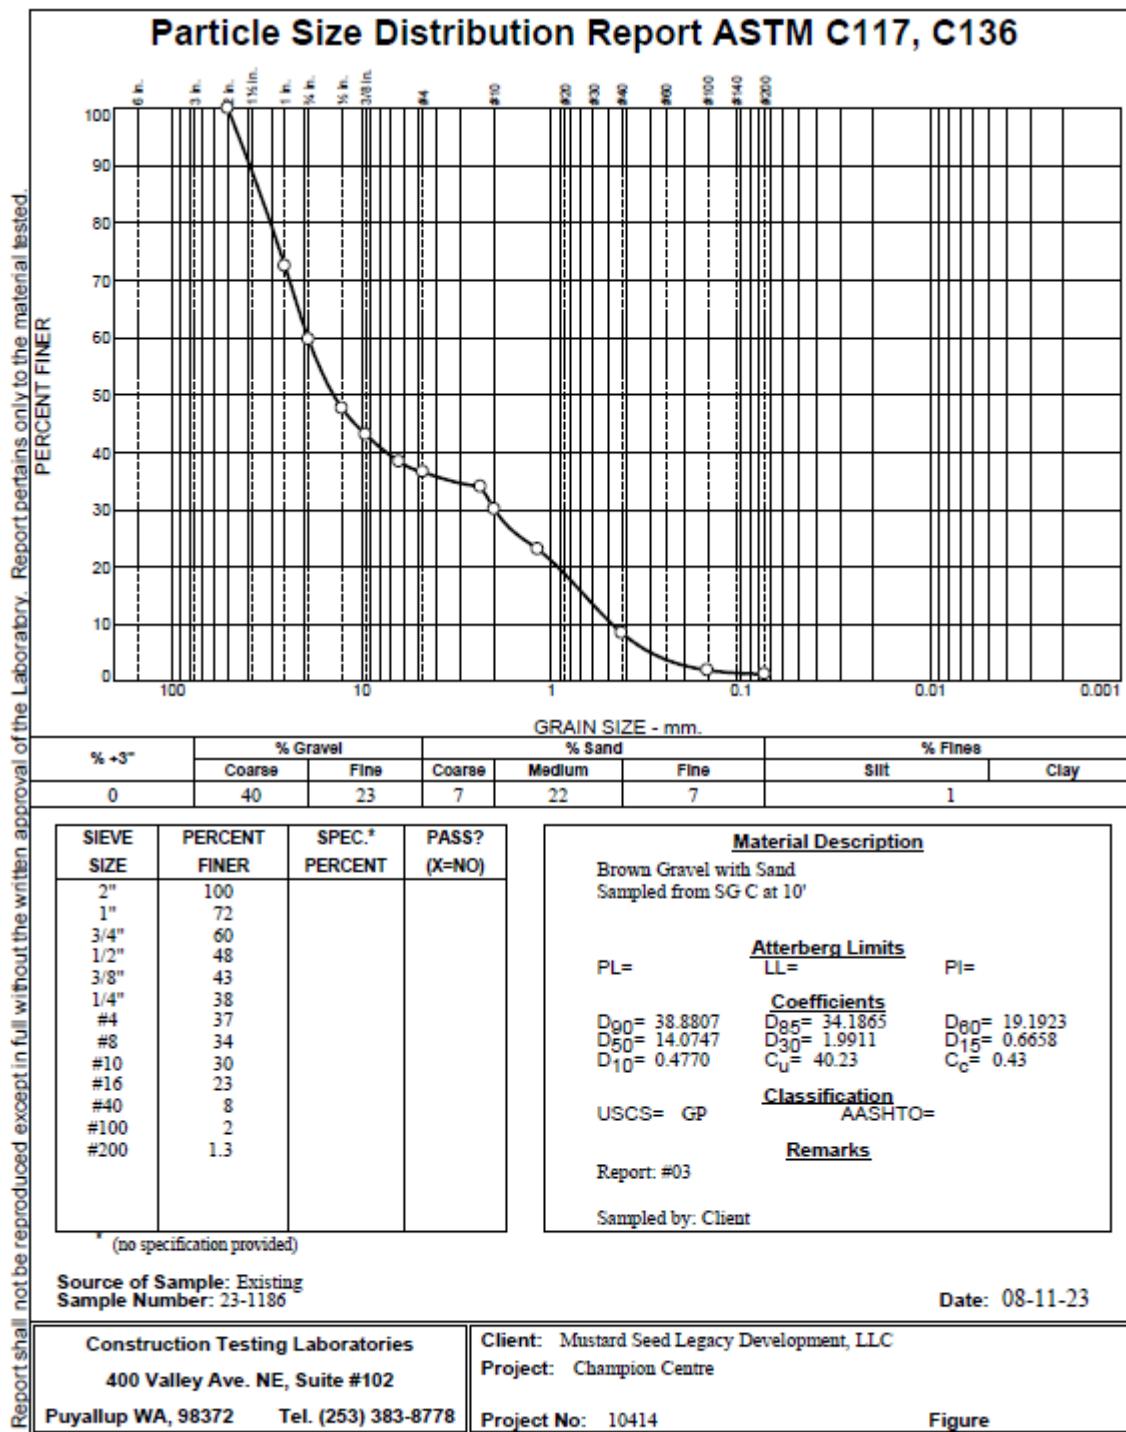
**See Attached Soil Test Results  
Below this Page**

**Runoff Control** – The subsurface soil characteristics are ideal for subsurface infiltration. The coarse outwash depth was verified to be at least nine to ten feet in depth but may continue to greater depths when considering the terrain and landform. Soils are excessively coarse and rapidly draining, such that infiltration testing is difficult to impossible. Attempts to presoak or even hold a static ponding level are not possible in this formation based on our experience on multiple occasions. Whether attempting a falling head test using a 6-inch pipe on neighboring sites with similar soil; the infiltration was too rapid to even establish ponding in the pipe. Therefore, we opted for a more conservative design rate sizing method by collecting soil samples from the approximate basal zone of the proposed trenches and delivered to Construction Testing Laboratory for analysis (copies attached).

**Results:** In this case, the test confirms that these very gravelly to extremely gravelly outwash soils are ideal for infiltration. The table below summarizes the sieve results for each sample along with the necessary correction factors to determine an appropriate design infiltration rate.

**Infiltration Rate for Design** - Given the substantial depth and excessive permeability of these coarse outwash soils, subsurface infiltration is ideal for stormwater control. The lowest-case recommended design rate for the three samples is 37.9 inches per hour per lab results and correction factors. We recommend using 30 inches per hour for design.
