Buffer Mitigation Plan

MUSTARD SEED LEGACY DEVELOPMENT LLC

BUFFER MITIGATION PLAN

APPENDIX A: PROPOSED SITE PLAN

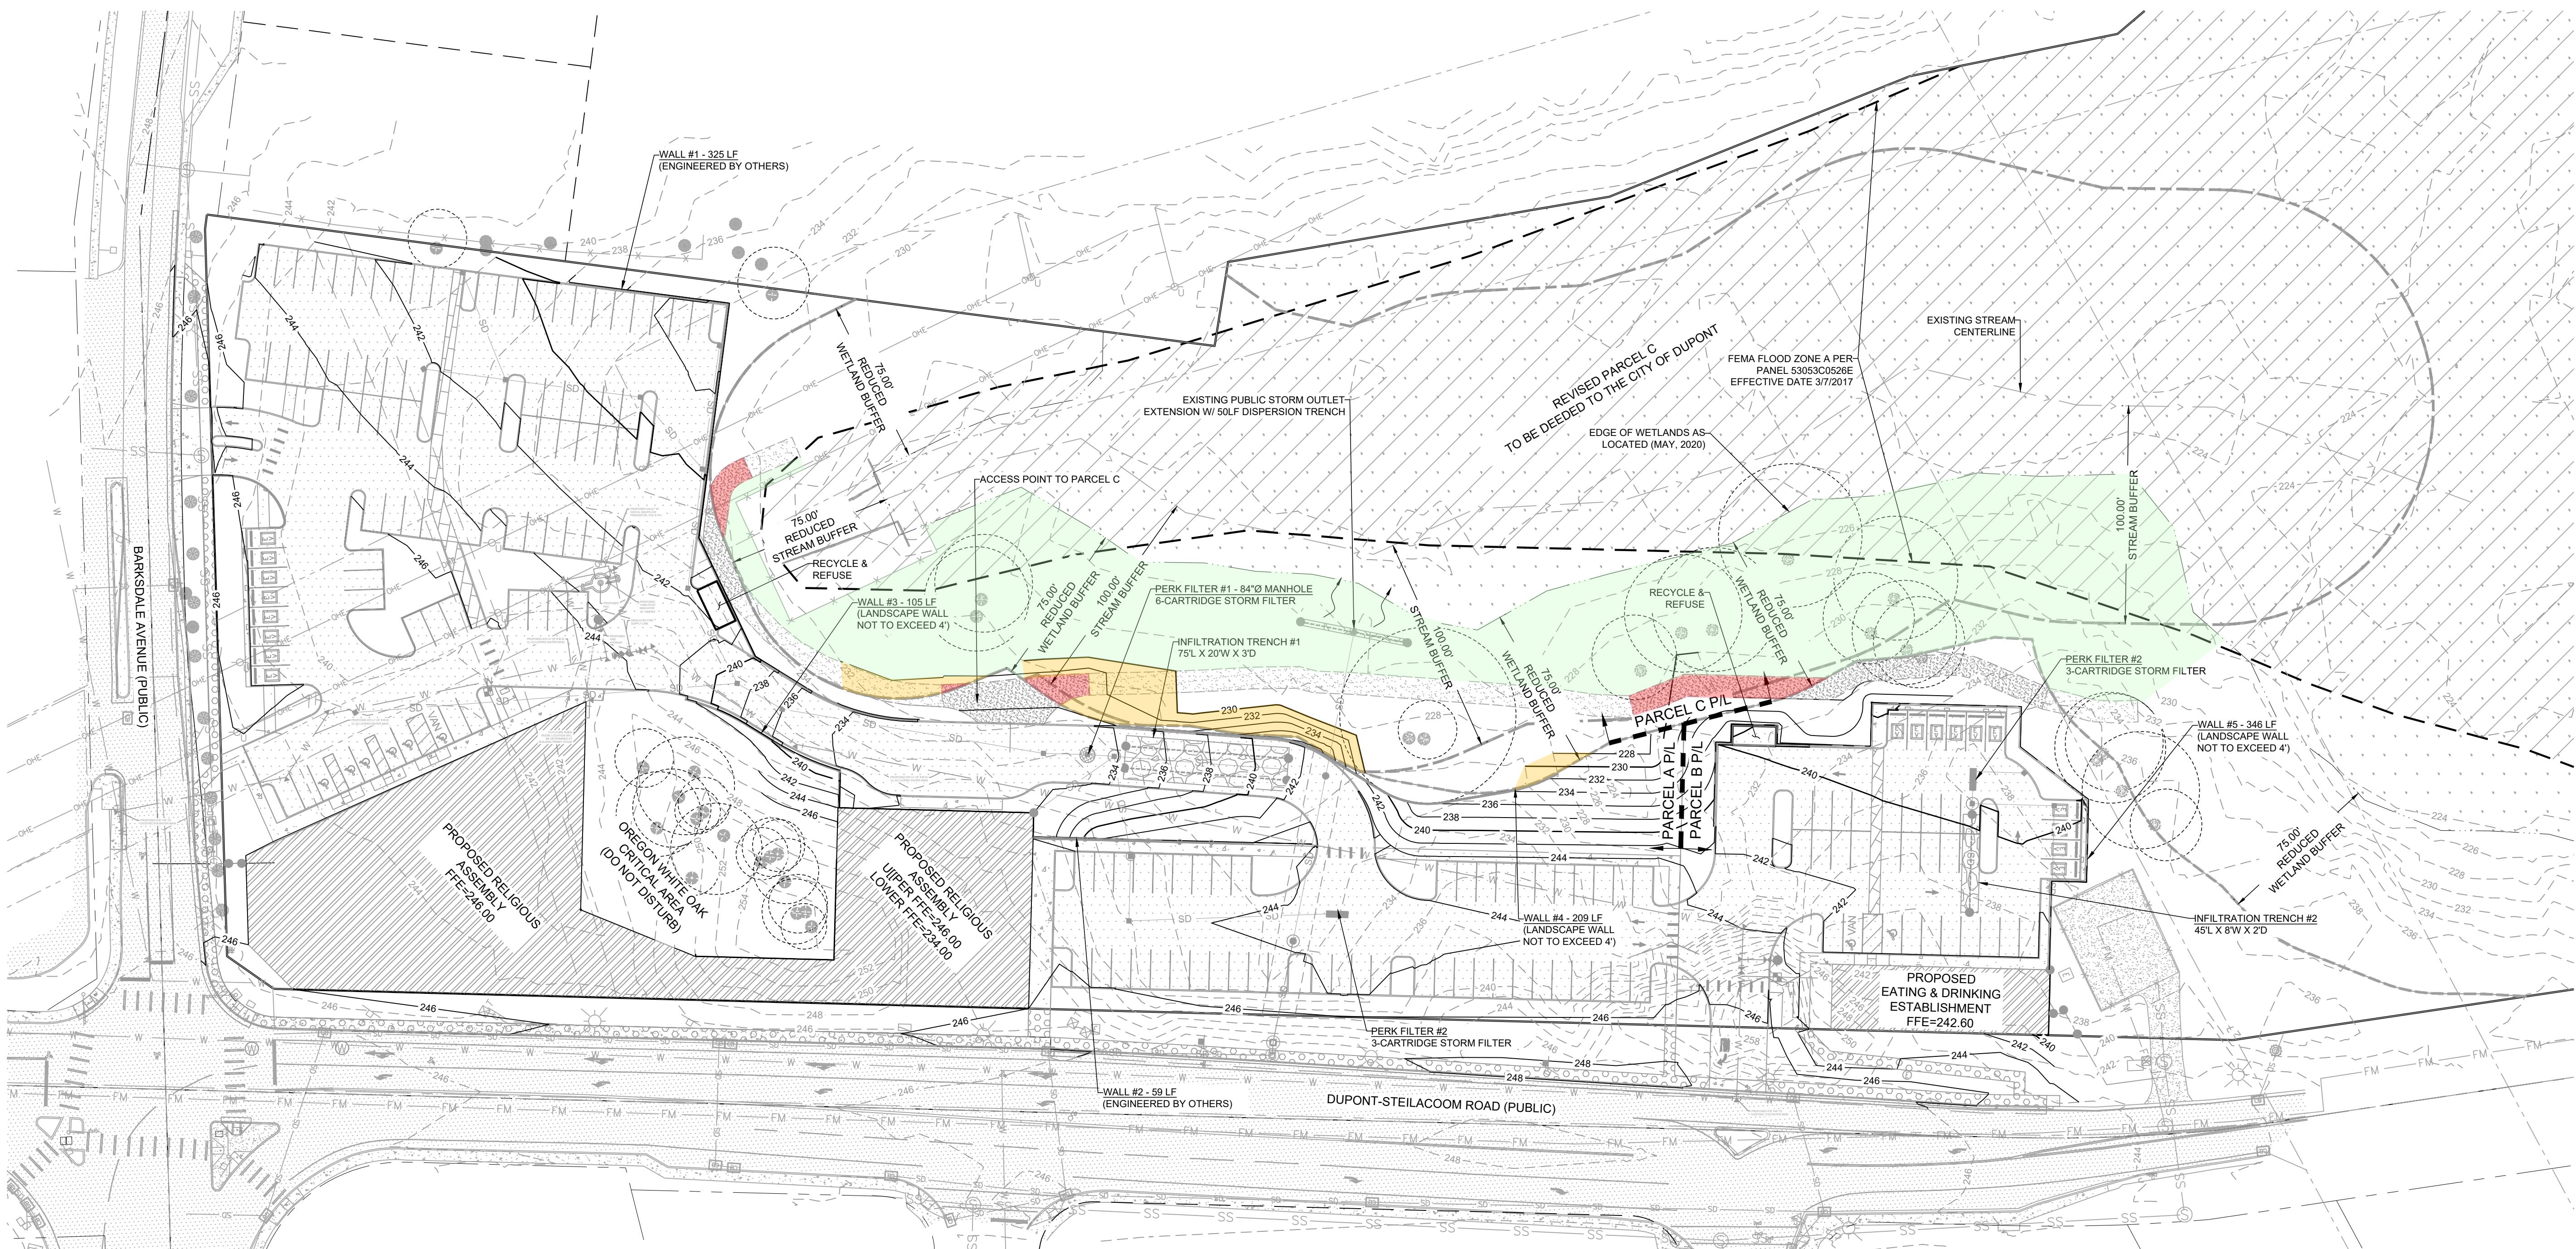
DRAWING
C1
SHEET 01
OF 01

PERMANENT BUFFER IMPACTS - 1,428 SQ FT

BUFFER ENHANCEMENT - 39,000 SQ FT

As noted below, the proposed project also involves upgrades to the existing access road within several small areas within the outer portion (approx. 1,428 sq. ft.) of the proposed reduced buffer (Appendix A, Table 3).

In addition, a flow dispersal trench will be installed within the wetland buffer to infiltrate clean stormwater. The trench will be installed in the central portion of the site immediately west of the access road (Appendix A). The trench will involve temporary grading and excavation impacts, and may require the removal of existing vegetation. The trench will be approximately 50 feet long by three feet wide, and approximately two feet deep, covering approximately 150 square feet (Table 3). Once the trench and all components are installed, the surrounding surface soils will be stabilized and replanted with native vegetation.

The project also involves temporary impacts to the buffer in the form of grading and filling (Appendix A). Areas temporarily disturbed by grading and filling will be stabilized and then restored with native vegetation. These areas will then continue to function as wetland buffer. The total area of temporary grading and filling within the buffer is approximately 2,834 square feet (Table 3).

Restoration of the approximately 2,834 square feet of temporary buffer disturbance that will occur during construction will be conducted. Once the temporary disturbances are completed and the areas have been stabilized, native buffer vegetation will be installed. Details are outlined in Section 5.2 (see temporary impacts shown in Appendix A).

In order to enhance the remaining buffer to allow for a buffer reduction per DMC 25.105.050(1)(b)(iv), native plantings will be installed in the buffer just northwest of the existing dirt access road. This area has approximately 39,000 square feet of planting area, but there is already an existing forest canopy so after invasive species have been removed, Grette Associates recommends that 173 trees and 910 shade-tolerant shrubs be planted among existing vegetation (Table 5).
