Stormwater Site Plan

Affinity at DuPont
DuPont, WA

Project Reference: C24-124

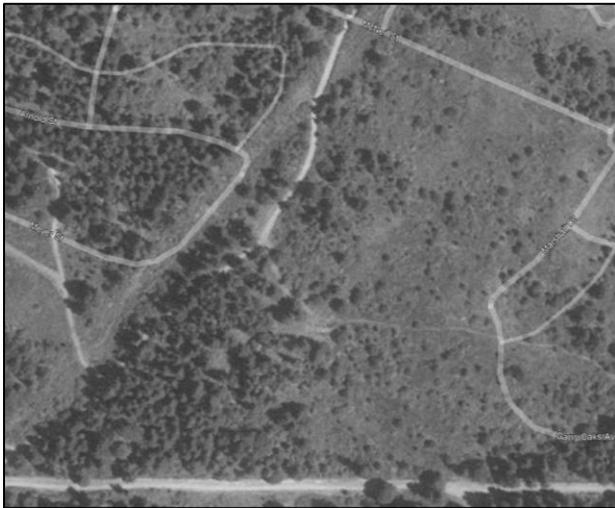
Figure 1: Existing Conditions (1990)

The project parcel is +/- 17.86 acres in size. The project site is currently vacant and undeveloped but has been previously subjected to some clearing and earthwork operations. The site topography generally descends to the south with about 45 to 50 feet of elevation change occurring across the site. Topographic change is nonuniform; the northern site area is relatively flat with about ten feet of topographic relief, while the southern site area possesses various sloping areas ranging from 0 to 40% and about 40 feet of elevation change. Today, the parcel is predominantly covered in grasses, shrubs, and trees with no evidence of concentrated discharge or runoff from the parcel. There are no known flooding problems downstream of the project site. There are no flow control facilities on the project site. See Figures 1, and 2, Existing Conditions Maps below.

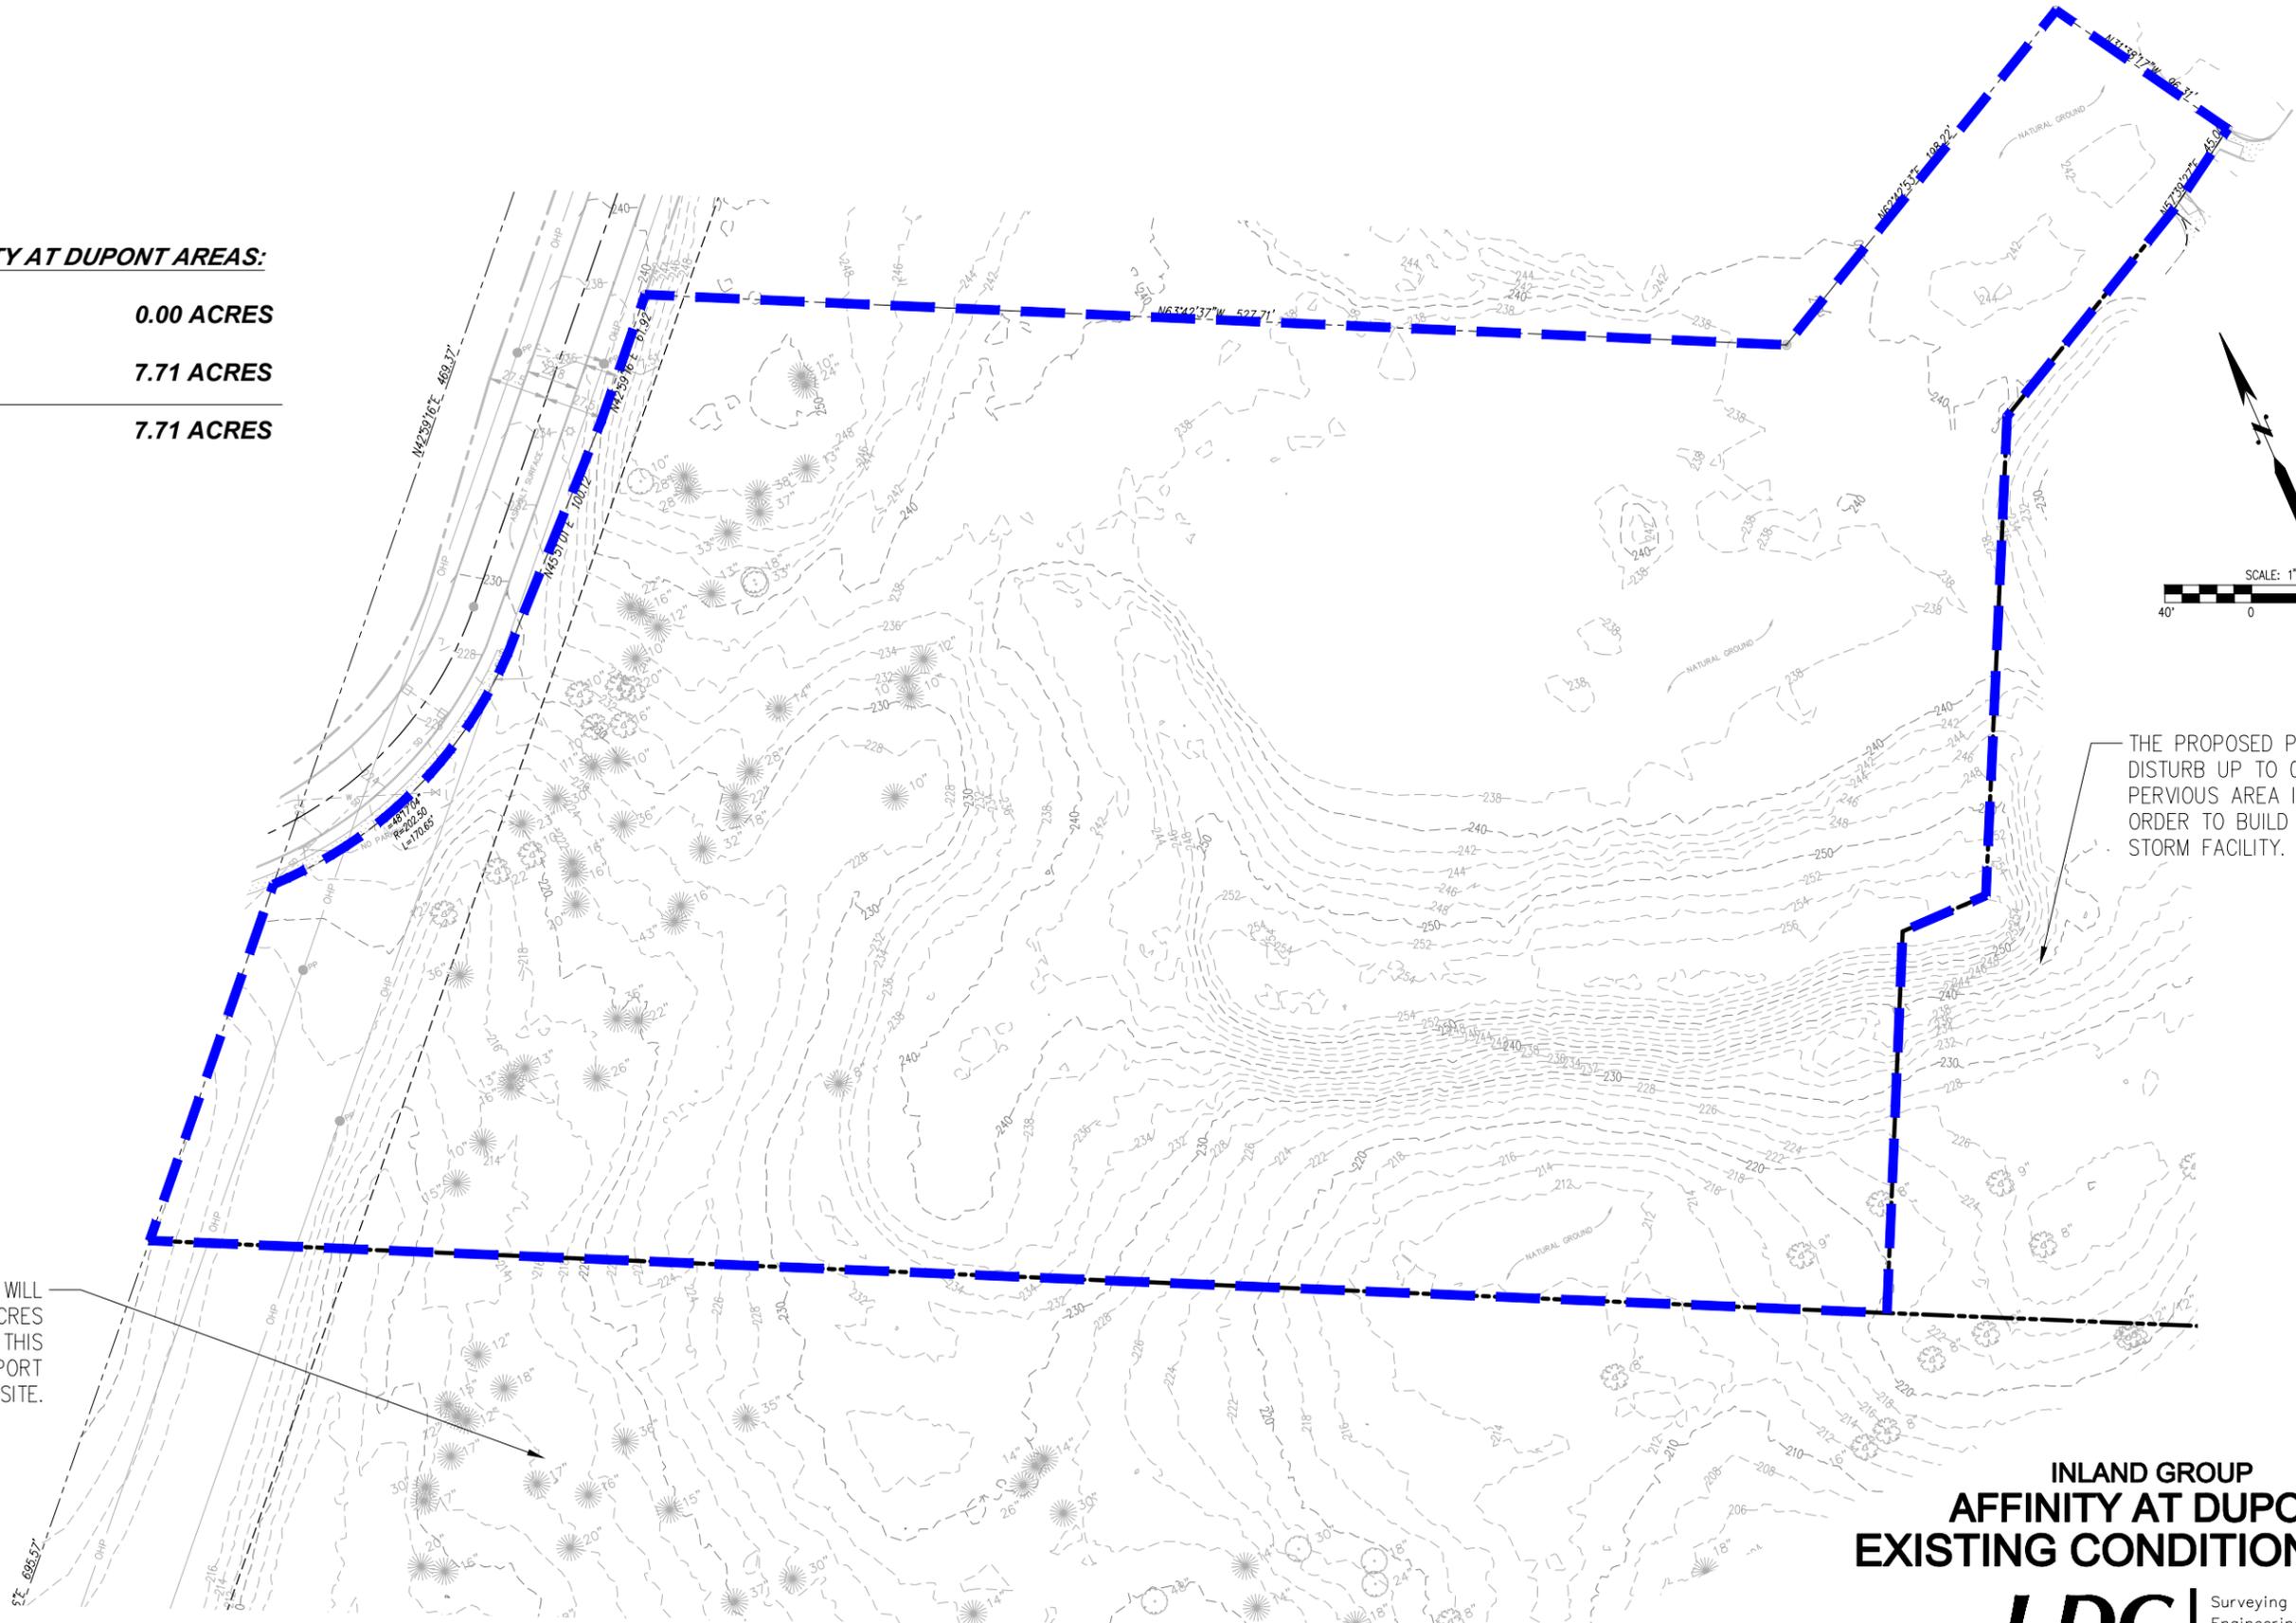
**INLAND GROUP
AFFINITY AT DUPONT
EXISTING CONDITIONS MAP**

EXISTING AFFINITY AT DUPONT AREAS:

IMPERVIOUS:	0.00 ACRES
PERVIOUS:	7.71 ACRES
TOTAL:	7.71 ACRES

THE PROPOSED PROJECT WILL DISTURB UP TO 3.58 ACRES OF PERVIOUS AREA IN THIS LOT TO STOCK PILE EXPORT FROM THE AFFINITY SITE.

THE PROPOSED PROJECT WILL DISTURB UP TO 0.10 ACRES OF PERVIOUS AREA IN THIS LOT IN ORDER TO BUILD THE REGIONAL STORM FACILITY.

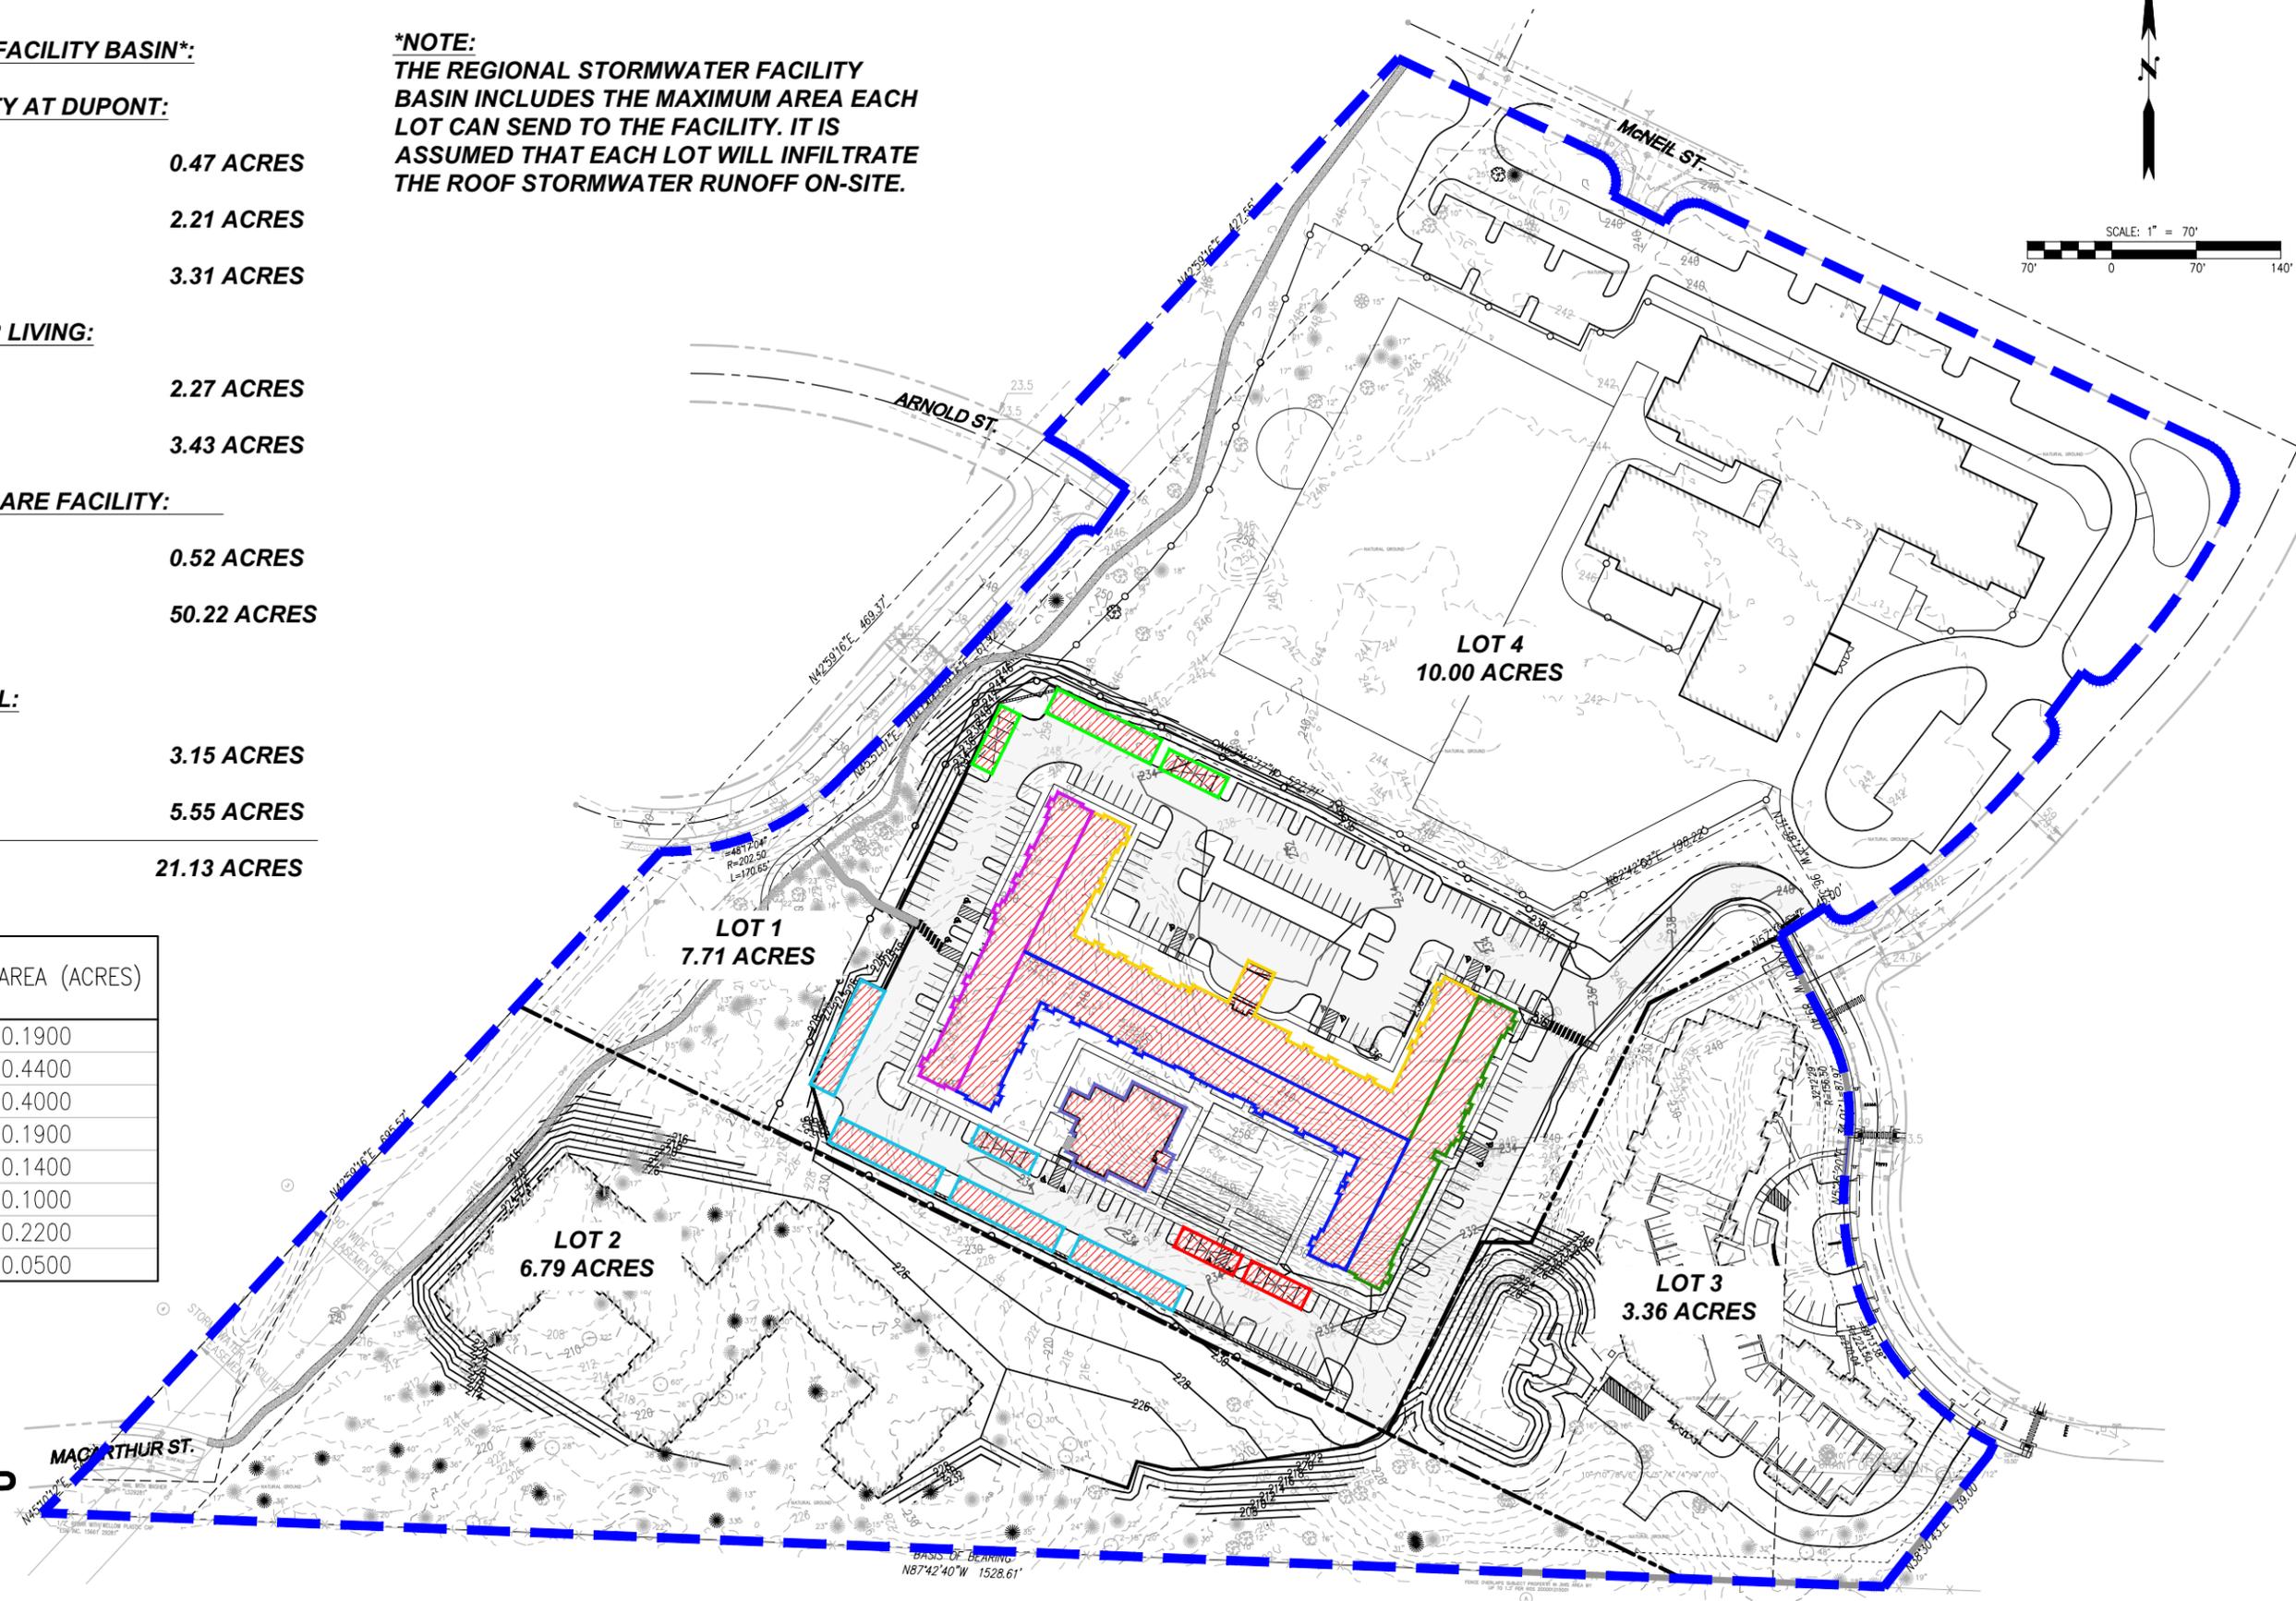
**INLAND GROUP
 AFFINITY AT DUPONT
 FLOW CONTROL MAP**

***NOTE:**
 THE REGIONAL STORMWATER FACILITY BASIN INCLUDES THE MAXIMUM AREA EACH LOT CAN SEND TO THE FACILITY. IT IS ASSUMED THAT EACH LOT WILL INFILTRATE THE ROOF STORMWATER RUNOFF ON-SITE.

The proposed Affinity at DuPont project is located on one parcel that is 17.86 acres located within the Patriot's Landing Master Plan area. The 17.86-acre parcel will be broken into three lots: Lot 1 – 7.71 acres, Lot 2 – 6.79 acres, and Lot 3 – 3.36 acres. See the Flow Control Map in **Appendix 3**.

The proposed shared infiltration pond was sized for the areas provided in Table 2 or a total of 8.62 acres of impervious surfaces and 12.51 acres of pervious surfaces. Per WWHM2012, in order to fully infiltrate the stormwater runoff generated by these surfaces, the infiltration pond must have a minimum bottom area of 4,500 square feet, 5 feet of live storage, 1 foot of freeboard, and 3 to 1 side slopes. See **Appendix 9** for the WWHM report.

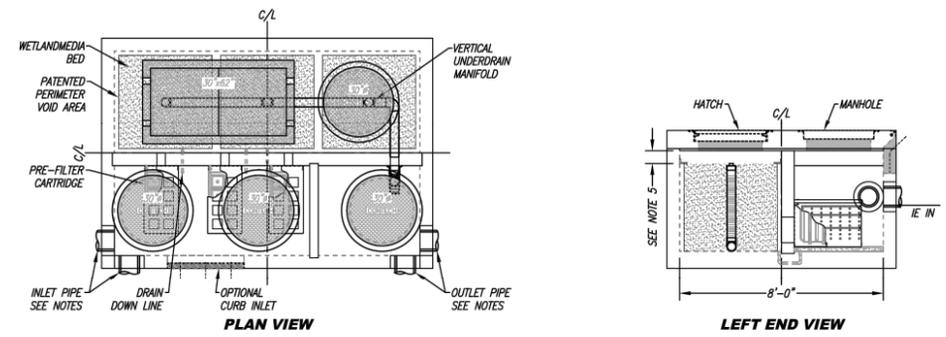
MWS-L-8-12-V-UG
STORMWATER BIOFILTRATION SYSTEM
STANDARD DETAIL

- ALTERNATE DEEP FRAME & COVER ORIENTATION USED WHEN CEILING TO MEDIA DISTANCE IS 2.5' OR GREATER.
- VERTICAL HEIGHT VARIES BASED ON SITE SPECIFIC REQUIREMENTS.

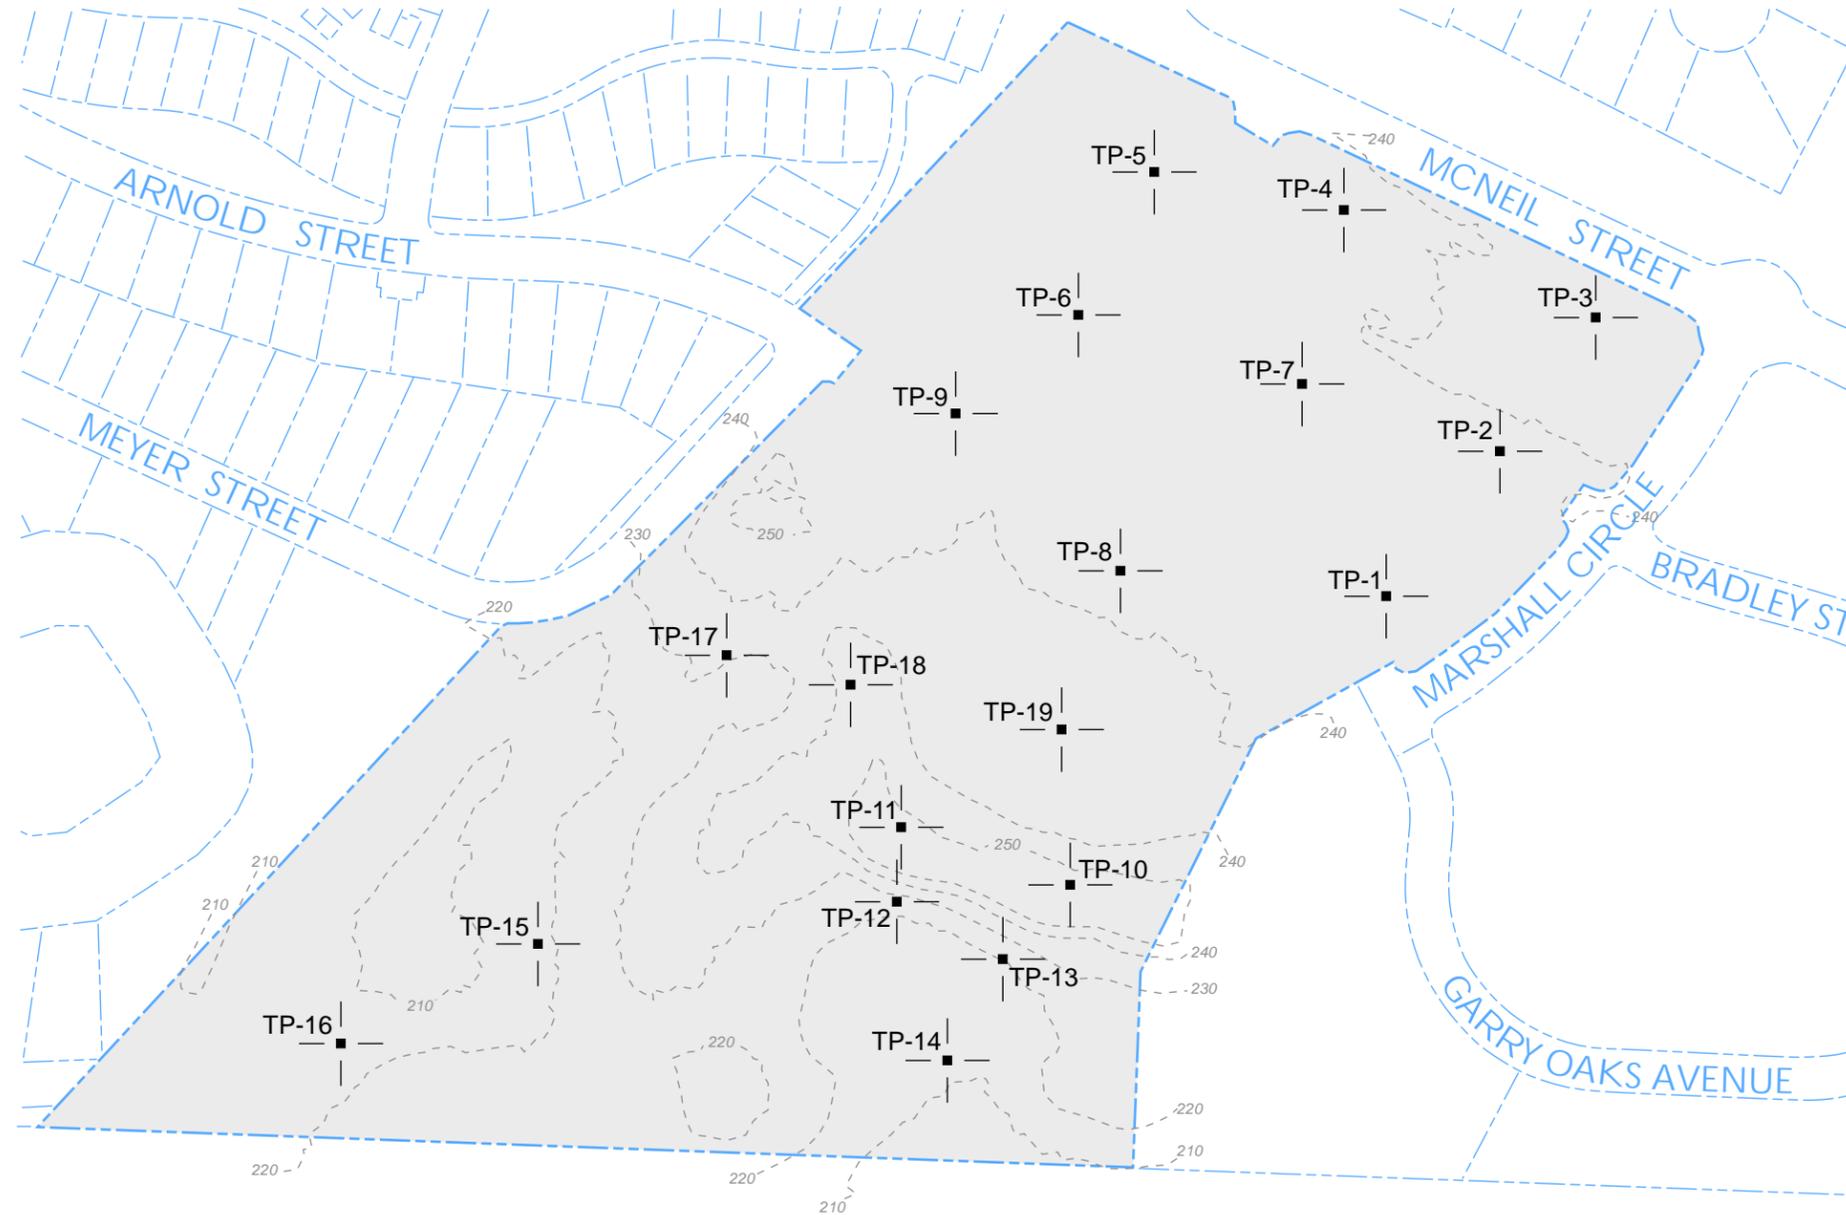
Drwn. By MRS
Checked By CGH
Date 04/25/2022
Proj. No. 7005.01
Plate 2

TP-1 | Approximate Location of ESNW Test Pit, Proj. No. ES-7005.01, Feb. 2022

A geotechnical investigation was conducted by Earth Solutions NW, LLC dated June 16, 2022. Nineteen (19) test pits to a maximum of 16.5 feet were logged and sampled from the February 16, 2022, investigation. The subsurface exploration indicated the site is underlain by native soils consisting primarily of recessional outwash with poorly to well-graded gravel with sand. Groundwater was not observed within any of the test pit excavations. Perched groundwater is not anticipated to develop within the recessional outwash deposit. Mottling or other signs of seasonal groundwater were not observed. Therefore, it is assumed the groundwater table is located below elevation 197.5. A long-term design infiltration rate of 20 in/hr within the recessional outwash was recommended. See **Appendix 5** for the geotechnical report.

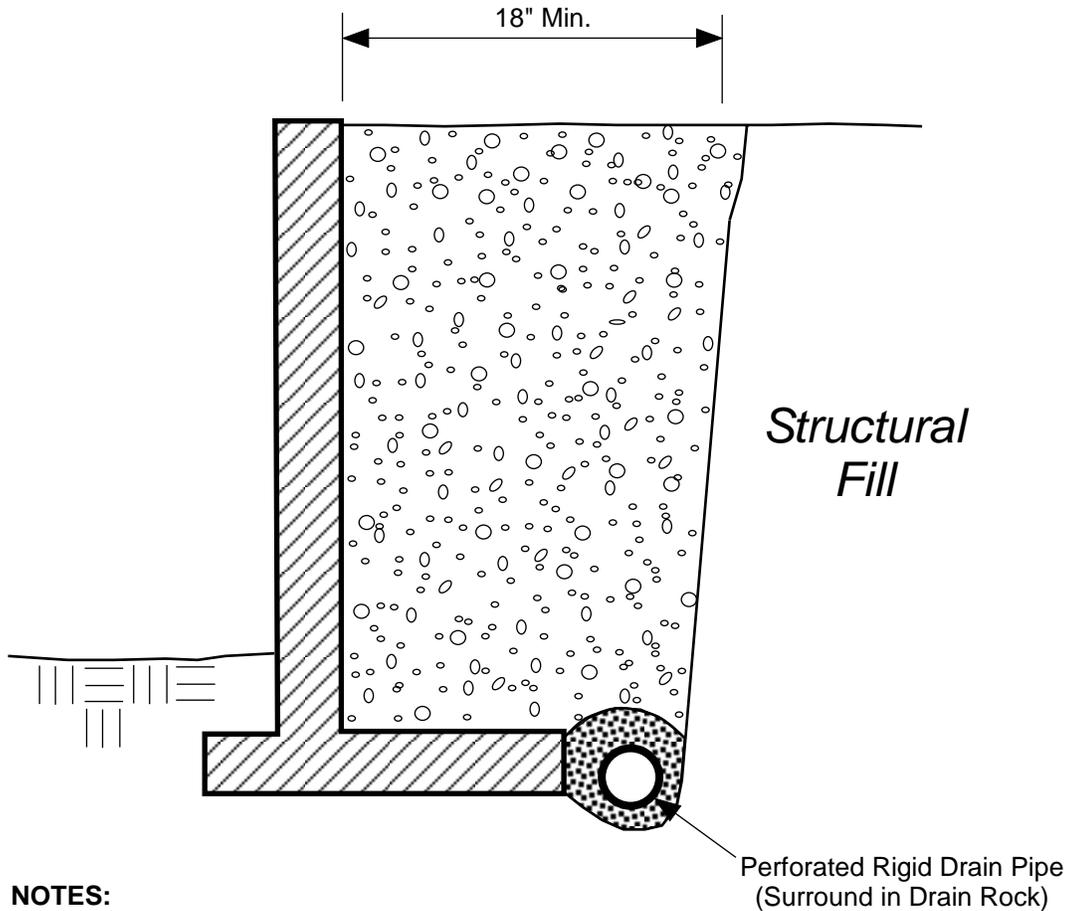
Drwn. MRS	Date 04/22/2021	Proj. No. 7005.01
Checked CGH	Date April 2022	Plate 3

- Free-draining Backfill should consist of soil having less than 5 percent fines. Percent passing No. 4 sieve should be 25 to 75 percent.
- Sheet Drain may be feasible in lieu of Free-draining Backfill, per ESNW recommendations.
- Drain Pipe should consist of perforated, rigid PVC Pipe surrounded with 1-inch Drain Rock.

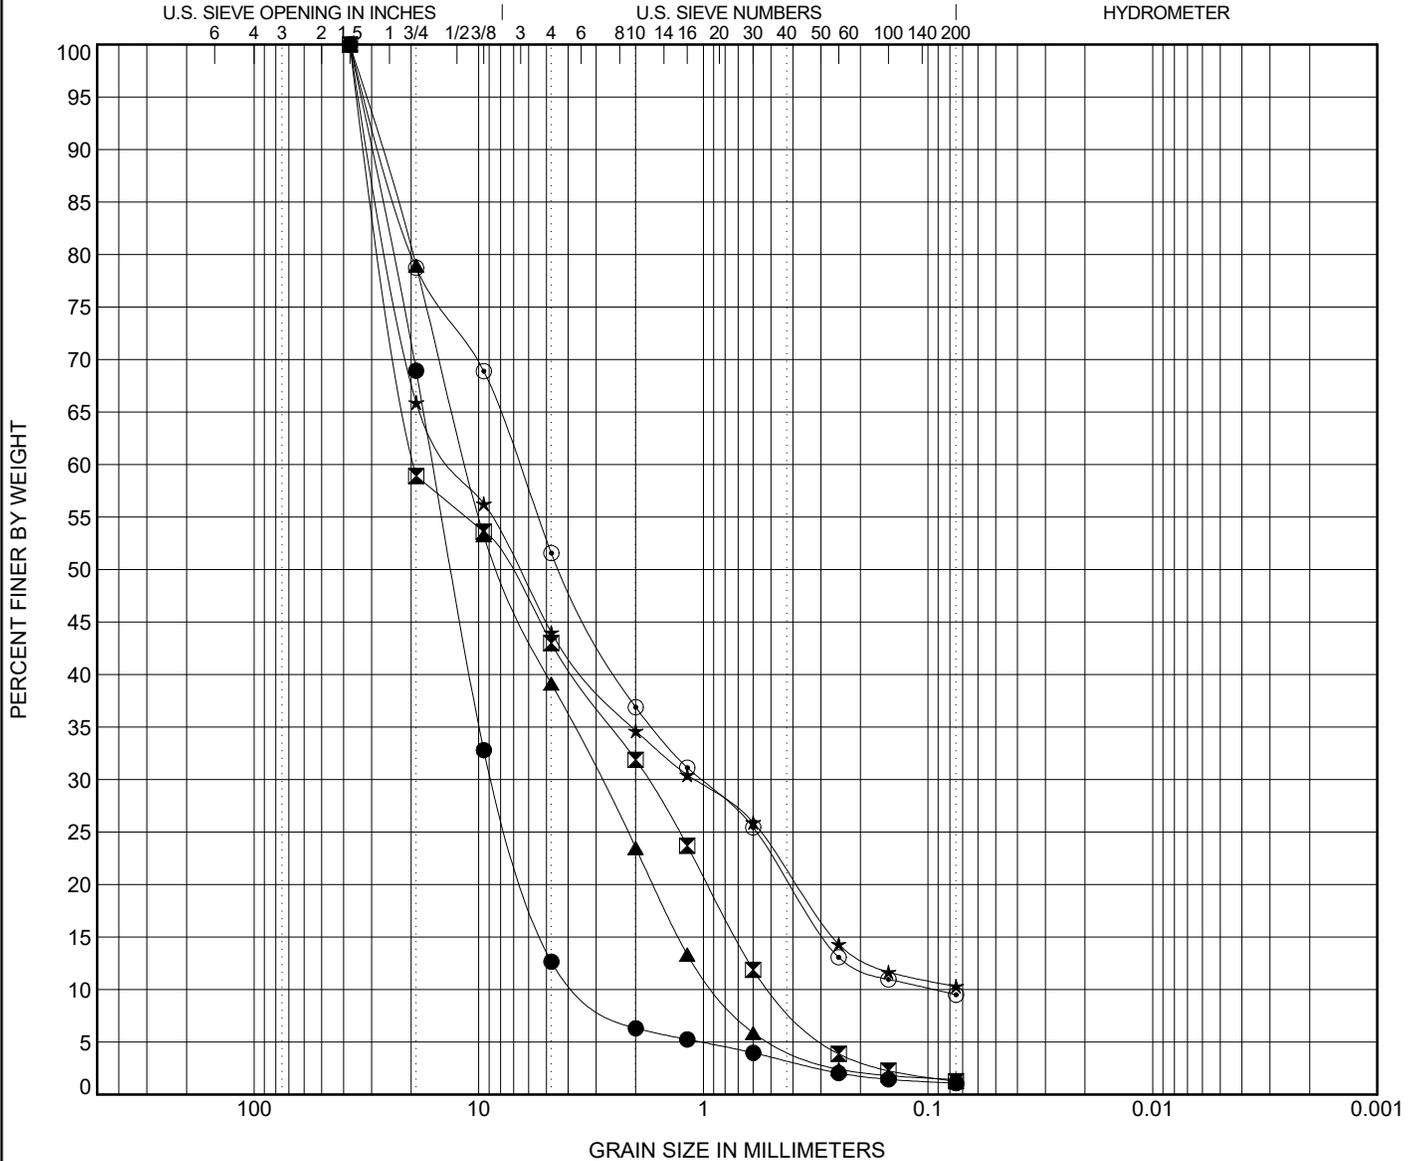
Specimen Identification	Classification						Cc	Cu
● TP-01 11.00ft.	USDA: Gray Extremely Gravelly Loamy Coarse Sand. USCS: GW.						1.41	4.84
⊠ TP-04 2.50ft.	USDA: Gray Extremely Gravelly Coarse Sand. USCS: GP w Sand.						0.33	39.60
▲ TP-08 16.50ft.	USDA: Gray Extremely Gravelly Coarse Sand. USCS: GP w Sand.						0.83	13.06
★ TP-10 9.00ft.	USDA: Dk Brn Extremely Gravelly Coarse Sandy Loam. USCS: GW-GM w Sand.						1.54	195.74
⊙ TP-11 18.00ft.	USDA: Dk Brn Extremely Gravelly Loamy Coarse Sand. USCS: GW-GM w Sand.						1.68	70.06

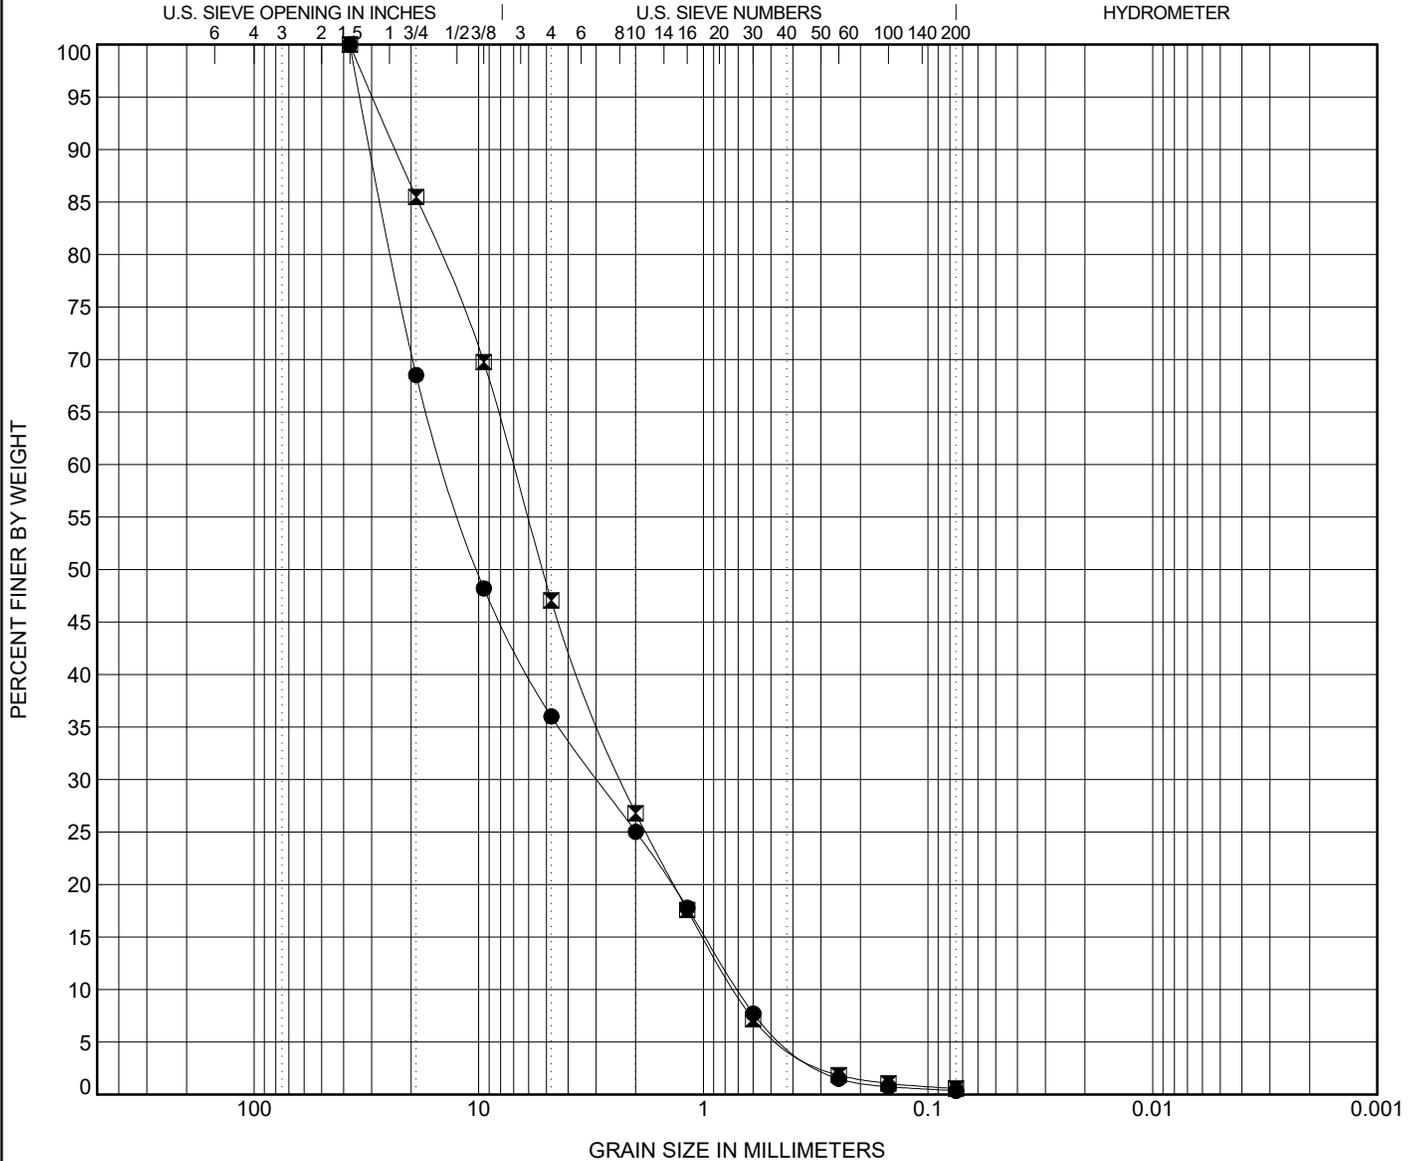
Specimen Identification	Classification				Cc	Cu
● TP-16 3.00ft.	USDA: Gray Extremely Gravelly Coarse Sand. USCS: GP w Sand.				0.88	20.31
☒ TP-17 4.00ft.	USDA: Gray Extremely Gravelly Coarse Sand. USCS: GW w Sand.				1.03	9.78

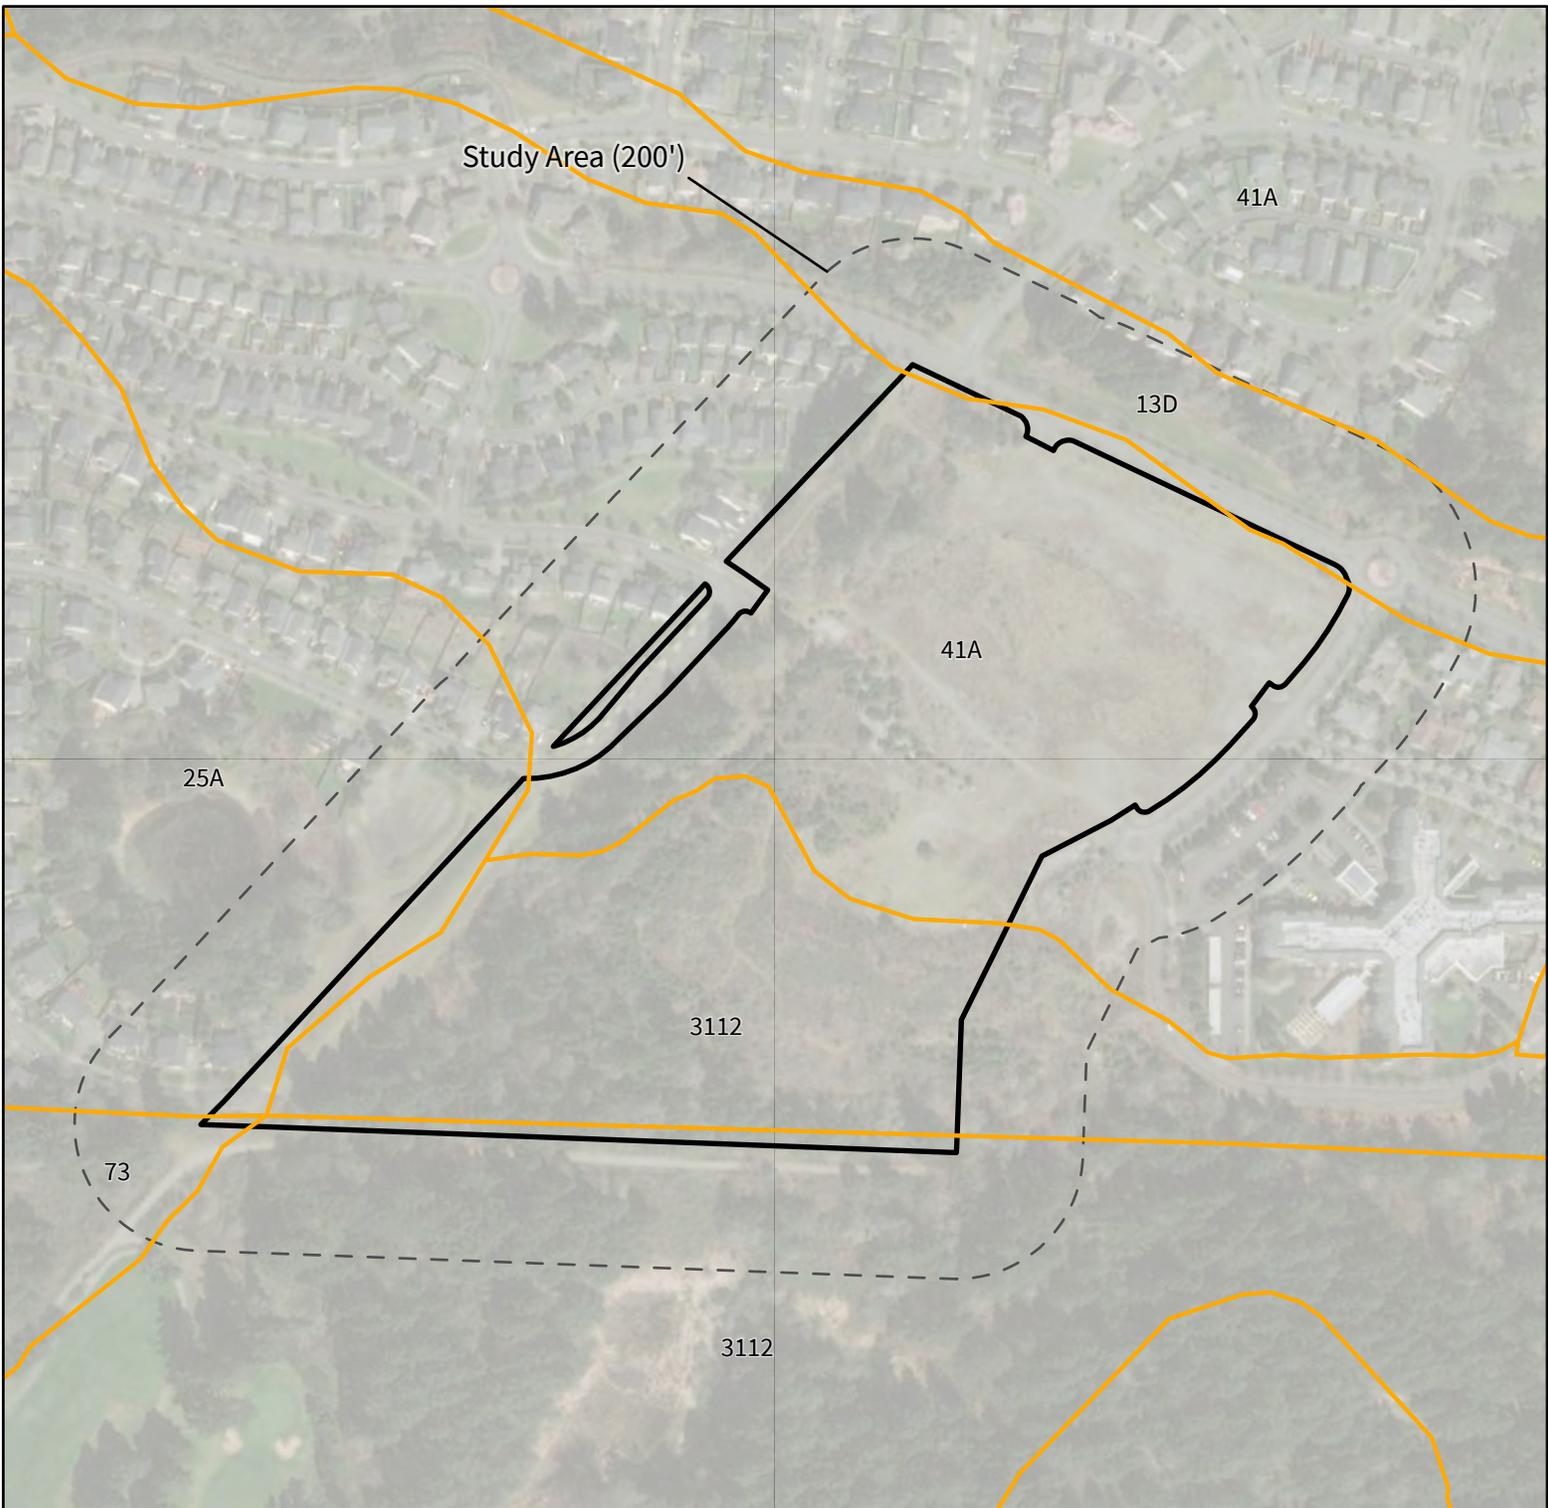
FIGURE 2

Soil Map Units Within Study Area - All not hydric
 13D - Everett very gravelly sandy loam, 15 - 30% slopes
 25A - Nisqually loamy sand
 41A - Spanaway gravelly sandy loam
 73 - Nisqually loamy fine sand, 0 - 3% slopes
 3112 - Everett-Spanaway-Spana complex, 0 - 30% slopes

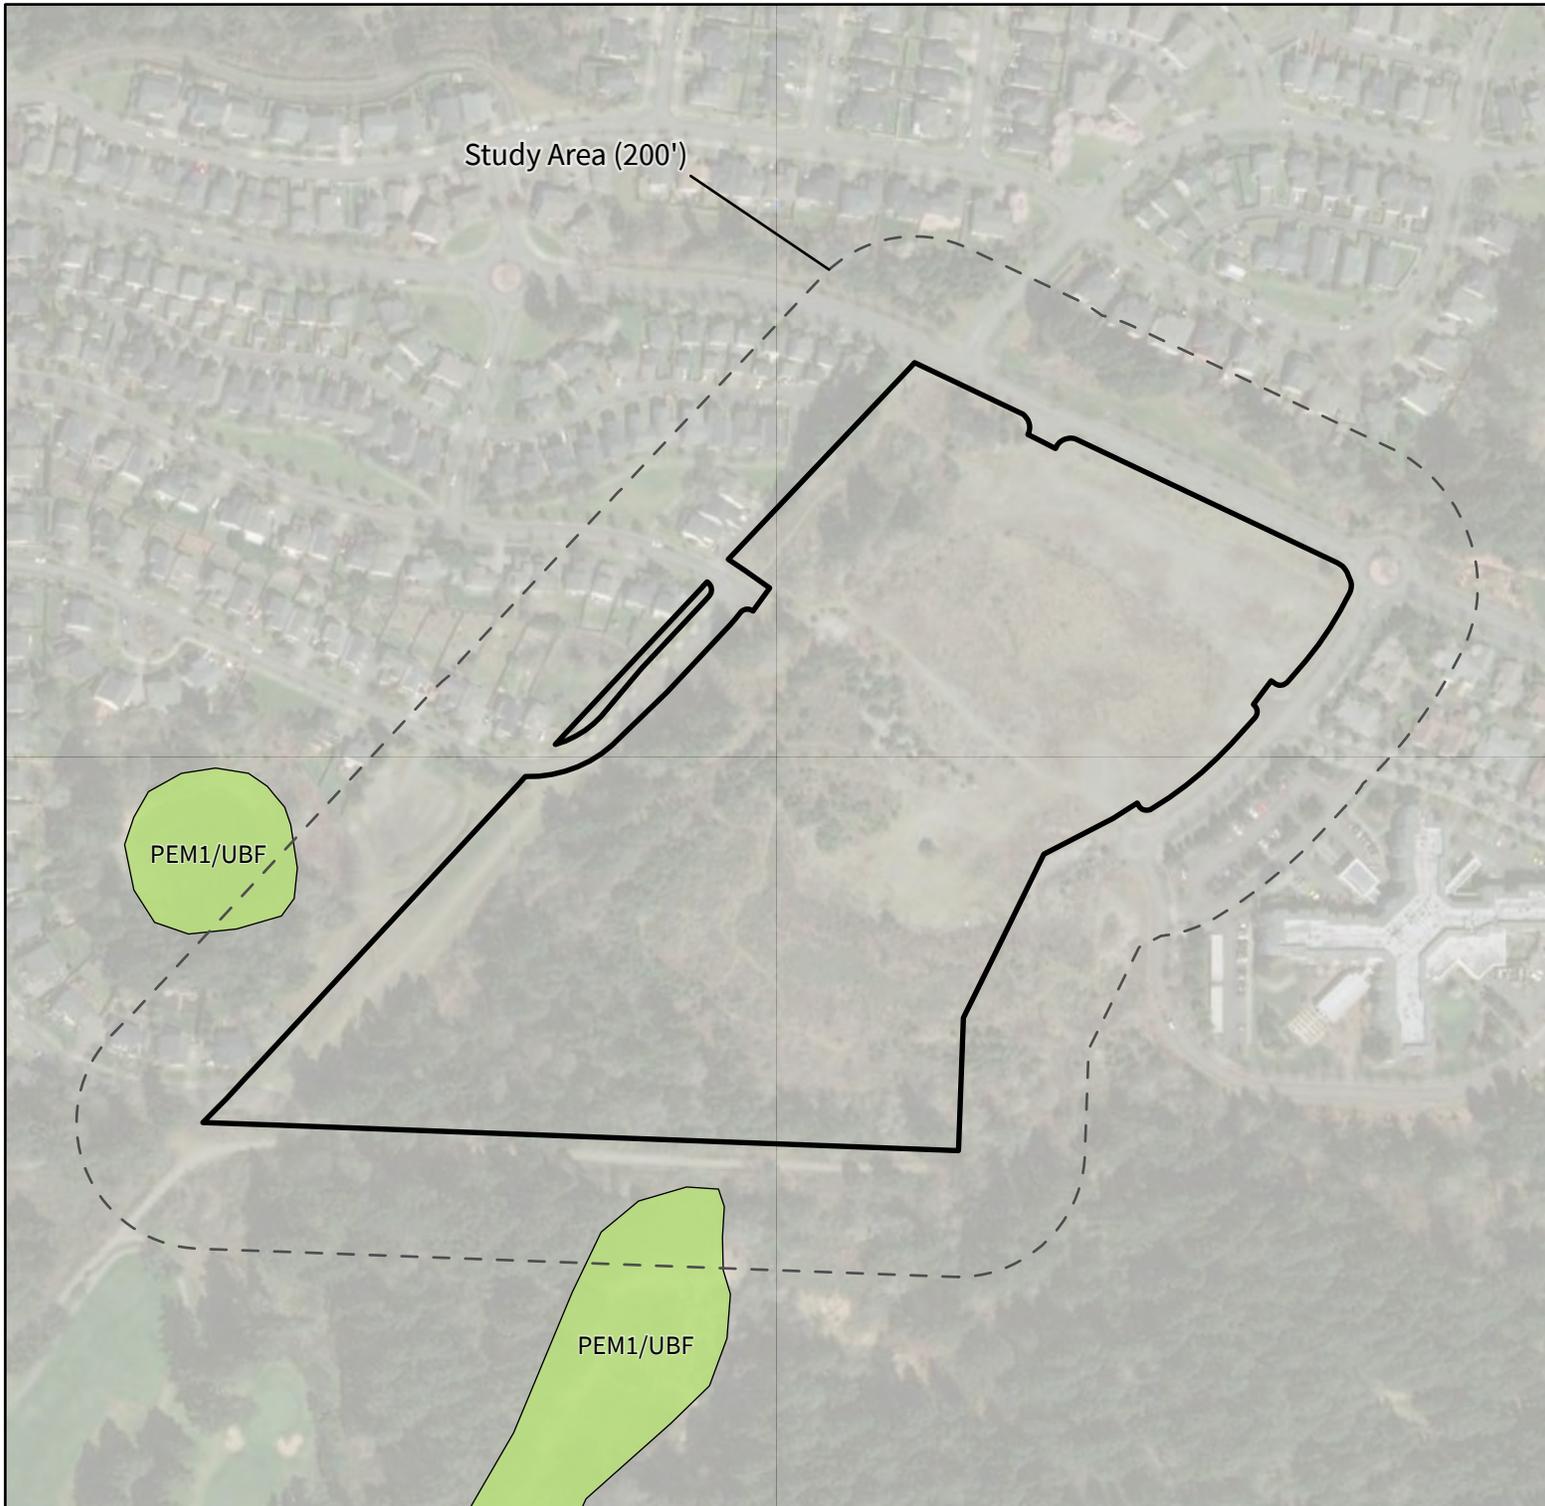
0071
 MAR 2022
FIGURE 3

NWI Mapped Wetlands Within Study Area

PEM1/UBF - Palustrine emergent persistent/unconsolidated bottom, permanently flooded

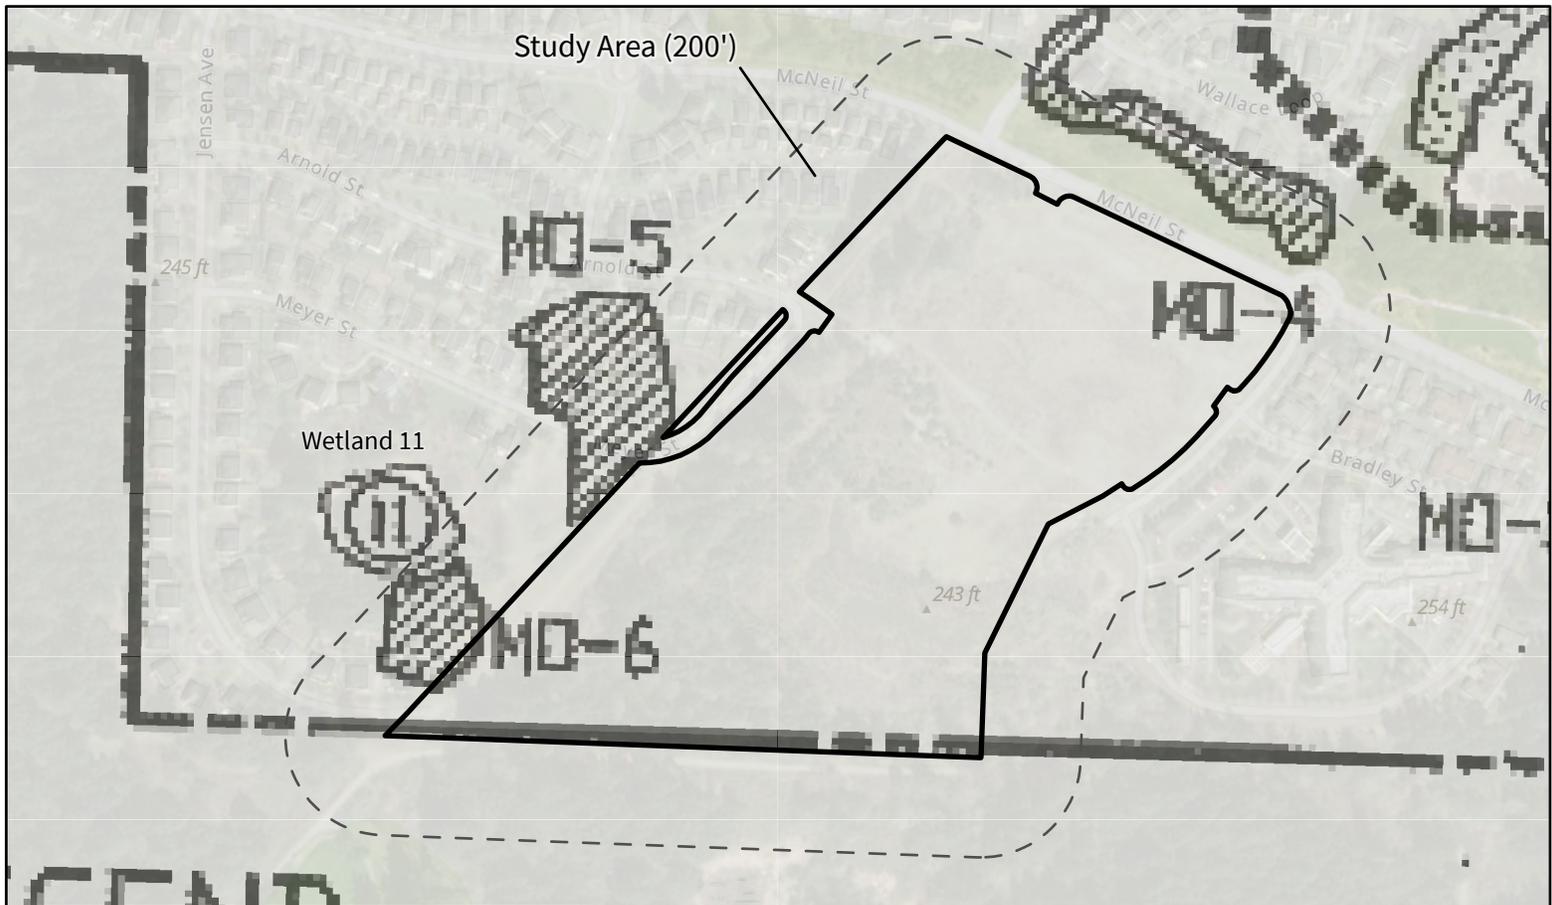
FIGURE 4

Type of Oak Woodland	Mapping Unit Number	Condition Class	Size (Acres)
Mixed	MU-1a	Low	8.9
Mixed	MU-1b	Moderate	6.7
Mixed	MU-2	Moderate	4.1
Mixed	MU-3	Moderate	1.4
Mixed	MU-4	Low	1.6
Mixed	MU-5	Low	2.5
Mixed	MU-6	Moderate	1.4
Mixed	MU-7	Low	1.3
Mixed	MU-8	Moderate	0.9
Mixed	MU-9	Moderate	2.2
Mixed	MU-10	Moderate	1.1
Mixed	MU-11	Low	3.5
Mixed	MU-12	Low	0.9
Mixed	MU-13	High	10.8
Mixed	MU-14	Moderate	1.3
Mixed	MU-15	Moderate	1.0
Mixed	MU-16	Low	0.9
Mixed	MU-17a	Moderate	8.0
Mixed	MU-17b	Moderate	8.1
Mixed	MU-18	Moderate	3.1
Dominant	0-1	High	28.5
Dominant	0-2	Low	1.4
Dominant	0-3	Moderate	0.4
Dominant	0-4	Moderate	0.6
Dominant	0-5a	High	4.1
Dominant	0-5b	Moderate	5.8
Dominant	0-6	Low	0.9
Total			111.4
