Stormwater Site Plan

Affinity at DuPont
DuPont, WA

Project Reference: C24-124

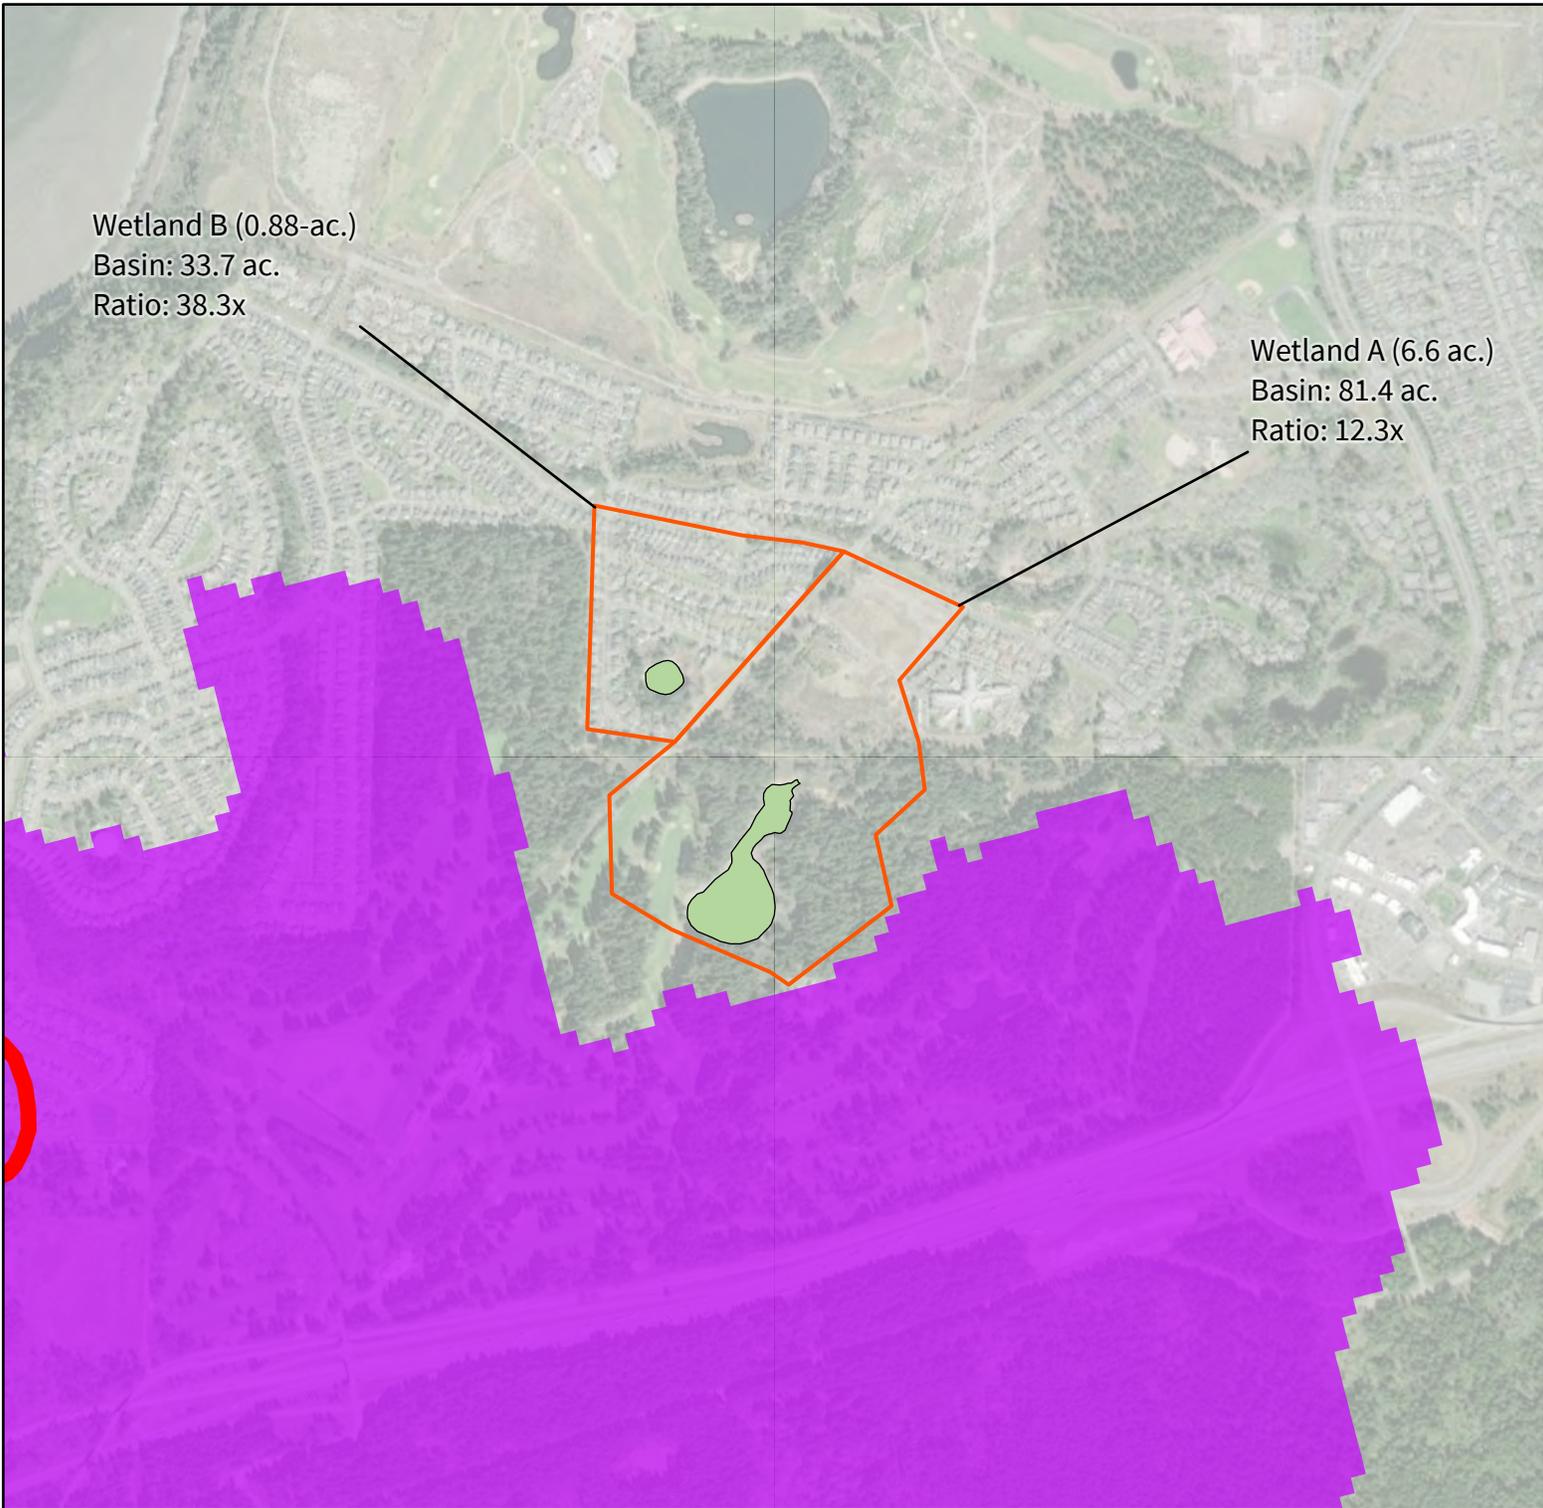
Wetland B (0.88-ac.)
 Basin: 33.7 ac.
 Ratio: 38.3x

Wetland A (6.6 ac.)
 Basin: 81.4 ac.
 Ratio: 12.3x
